First Production Batch

43 Lancaster MkIs Serial Range

L7527 - L7584

Oct 41 - Mar 42

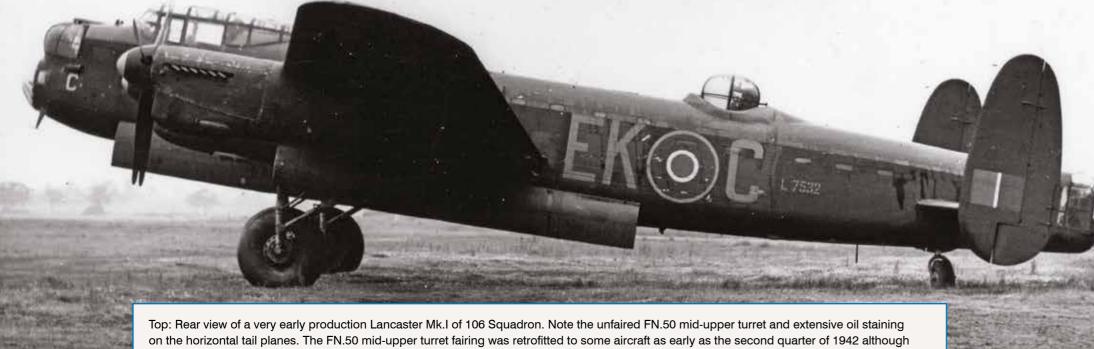
Above: L7532 was the sixth production example and was delivered to 44 Squadron in December 1941. It appears to have flown no operations, simply being used as a training aircraft by eight different units before ending its days with 1656 HCU as seen here. Note the retrofitted mid-upper turret fairing, DF correction strip (see page 78), windscreen de-icer fairings, later IFF aerial and FN.120 rear turret.

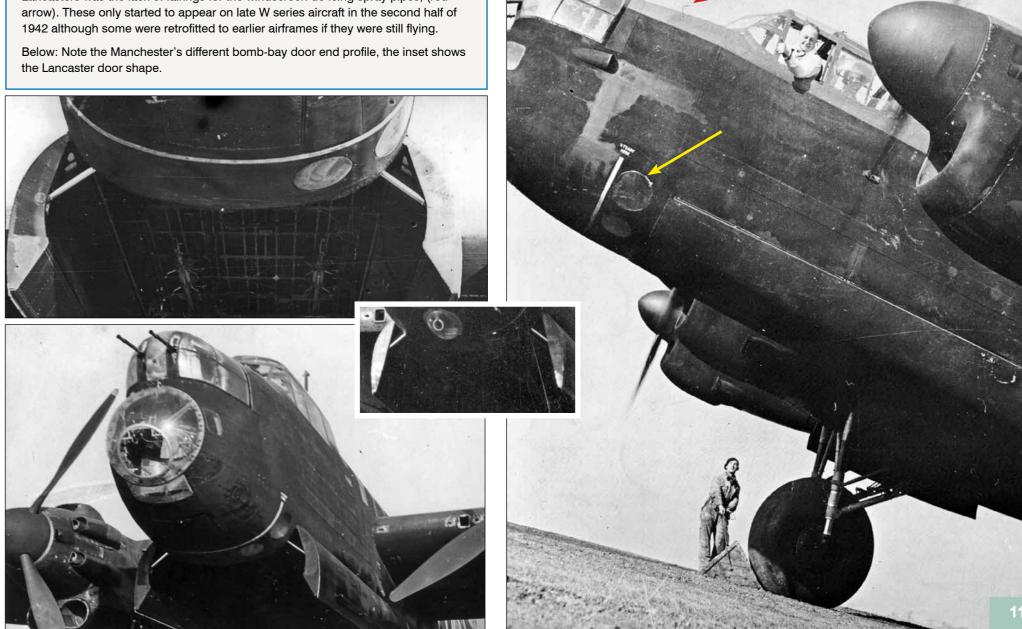
Right: One way to recognise a very early L series Lancaster is the second camera port (yellow arrow) immediately between the 'Steady Here' stencil and the bomb bay on the port side. This was carried over from the Manchester as can be seen below. The original camera port below the nose was retained on all Lancasters but the perspex cover was soon removed in service. Another feature of very early Lancasters was the lack of fairings for the windscreen de-icing spray pipes, (red
