MARKINGS

STIRLING Mk IV LK555, E7-S, '555 STATE EXPRESS', 570 SQUADRON, MARCH 1945

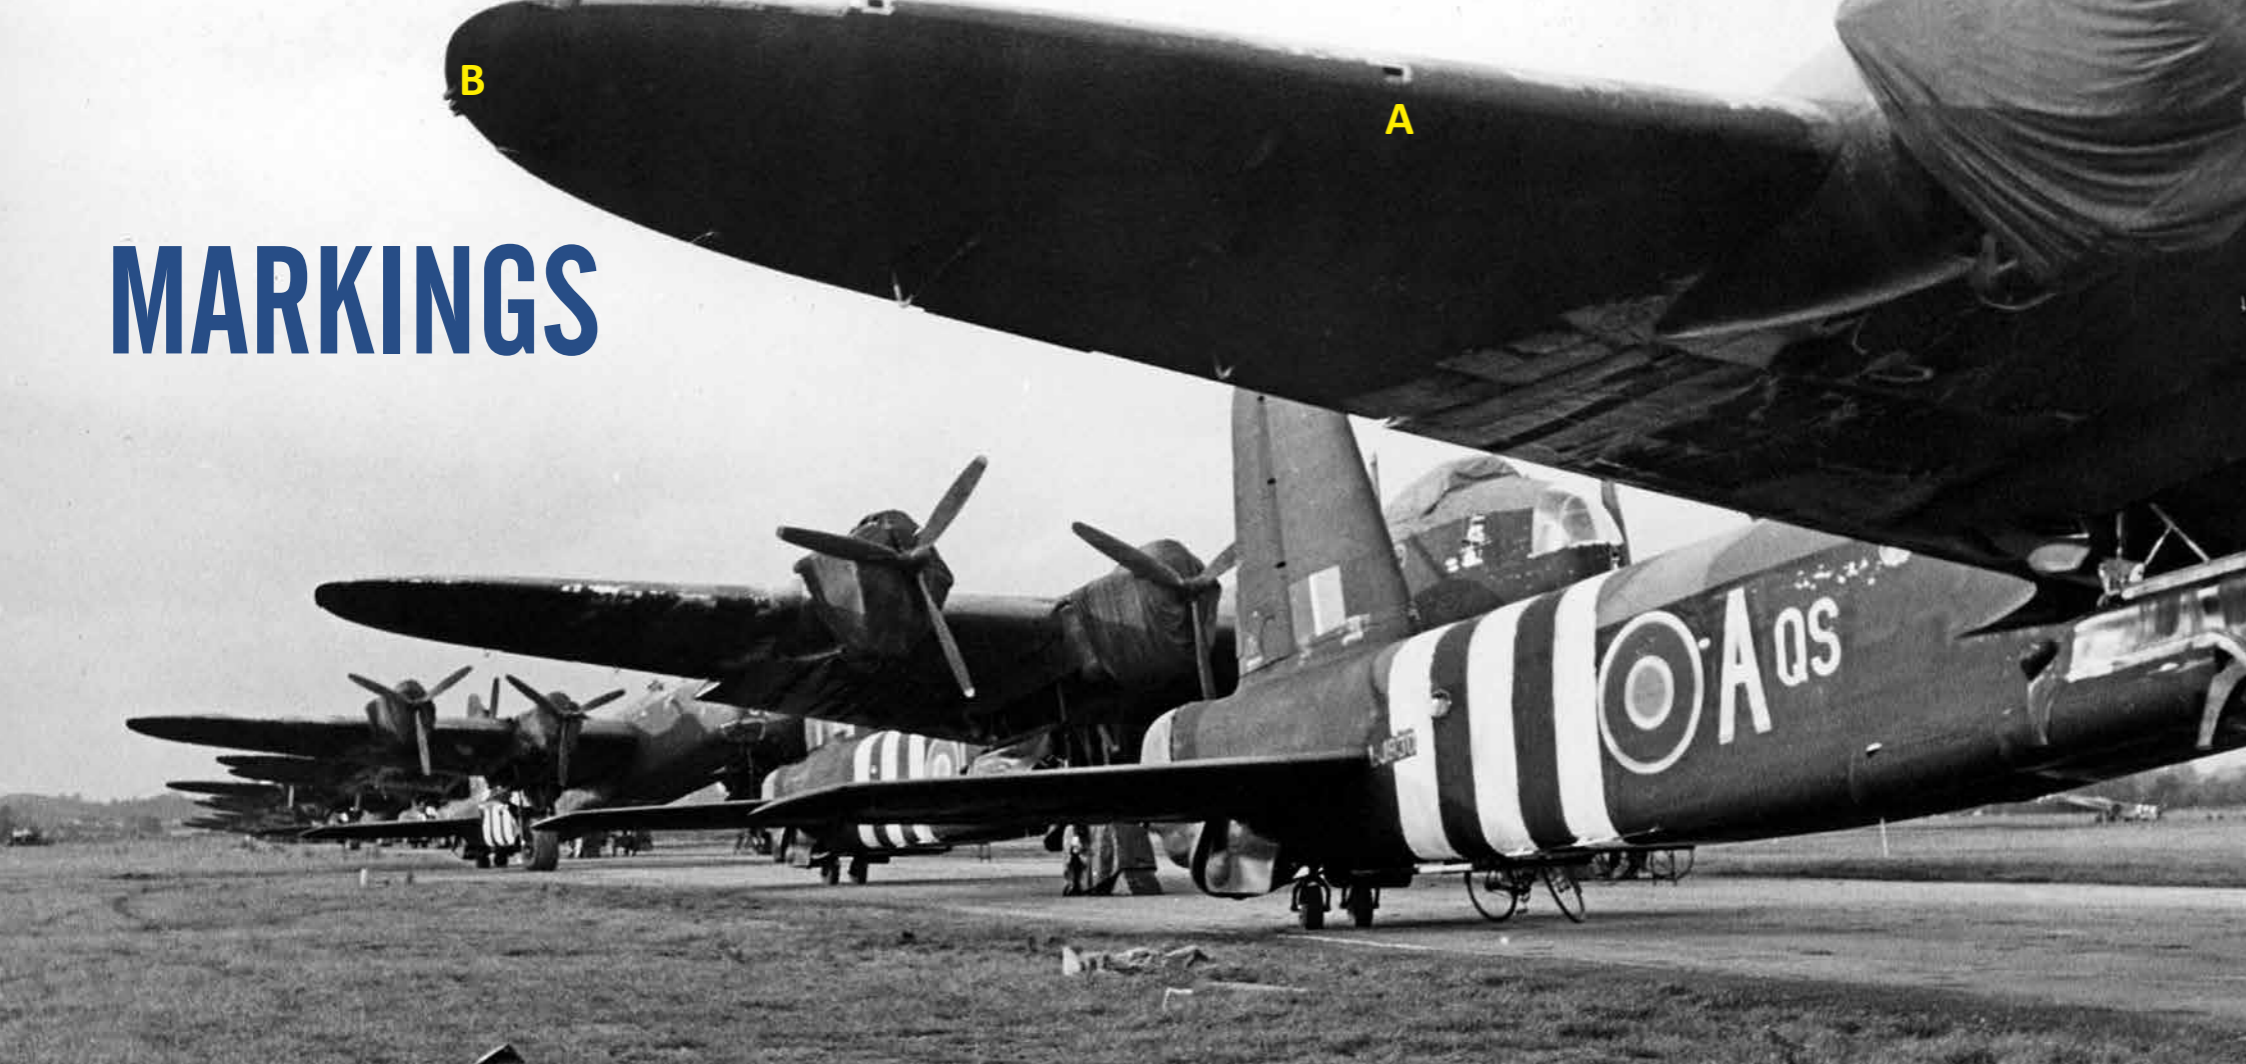
During the Stirling's service with Bomber Command the squadron codes painted on the fuselage generally conformed to a regulation size and colour. When squadrons were transferred to 38 Group and they were re-equipped with the Mk IV in 1944 – and later when they came under Transport Command – codes varied considerably in size, positioning and character spacing.

620 Squadron was alone among the Stirling transport units in adopting small unit code letters and a large individual identity code letter displayed on the rear fuselage sides in a single three-letter sequence, not divided by the roundel as was the official format. This was its solution to displaying the squadron code letters after they had been covered by the invasion stripes.

This is LJ930, QS-A, delivered to 620 Squadron on 16 May 1944, flying four trips to Arnhem where it was badly damaged by flak on 23 September and sent to SEBRO, (Short Bros Repair Organisation at Cambridge), for repair, before passing to 190 Squadron with whom it was lost in a flying accident on 20 April 1945. Note the recesses on the wing leading edge for balloon cable cutters (A) and the Mk IV's new tubular style formation lights on the rear of the wingtip, which replaced the clear perspex segment seen on early Stirlings.

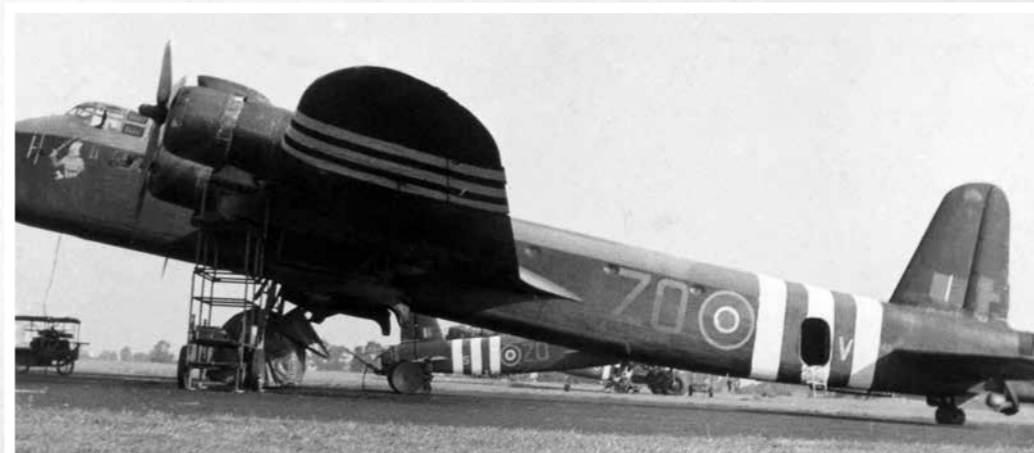
Below: In another local variation of squadron markings, 196 Squadron's EF248, ZO-V, displays the standard Dull Red full-size squadron code 'ZO', but the individual identity letter 'V' is very much smaller and superimposed on the second black stripe, possibly in white or medium sea grey. The serial number 'EF248' has been partially overpainted, leaving only '48' fully visible. Underneath the pilot's window is a cartoon of what could be a sword-wielding warrior with the legend 'To Victory' in script beneath. Note, also, the patched rudder and tailplane. EF248 was lost to flak over Arnhem on 19 September.

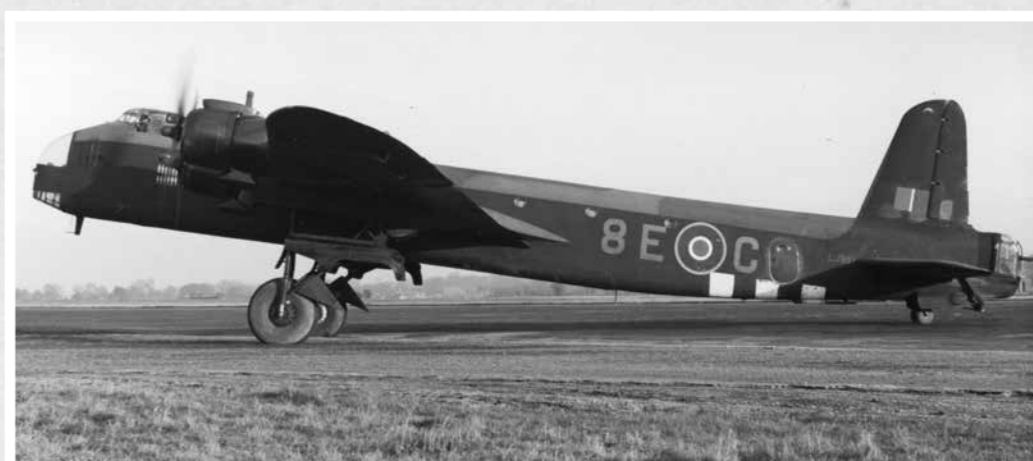
Above: No 295 Squadron's LJ951, 8E-C, shows yet another variation, with smaller, flattened bold letters in the standard Dull Red, with wider spacing between the number and characters. The aircraft carries cut-off invasion stripes beneath the rear fuselage and an indication that those under the wing have been painted out. The rudder and fin also show evidence of repair. LJ951 displays 12 dagger op symbols beneath the pilot's window.

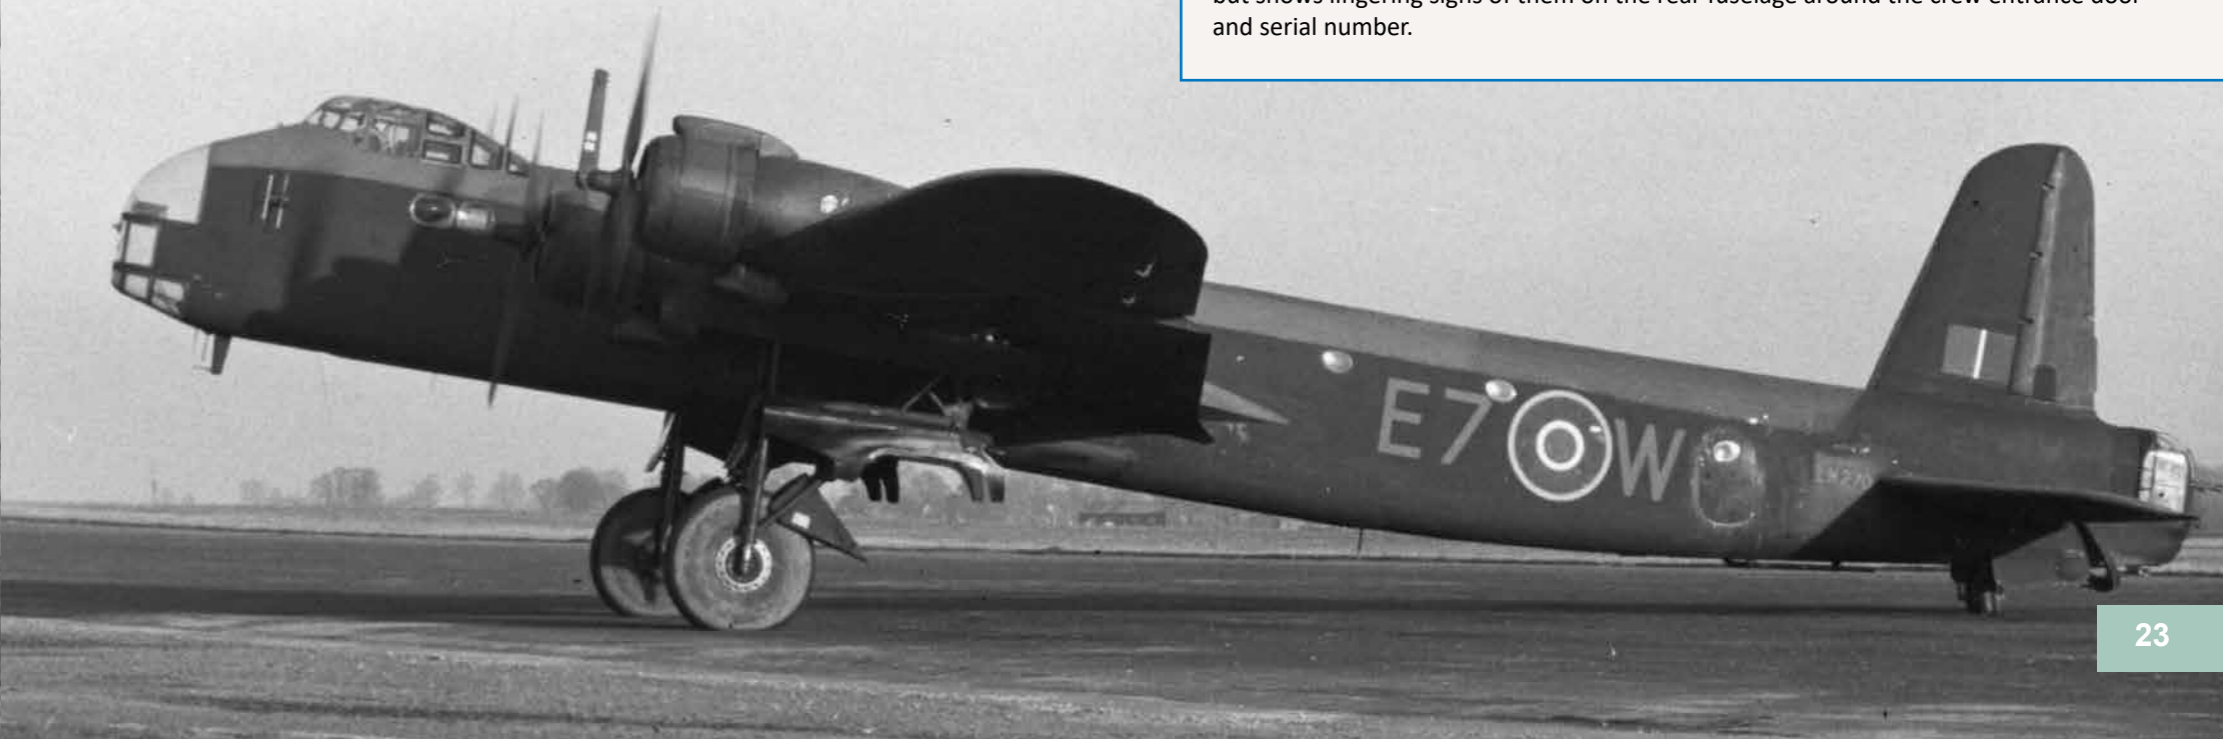
Below: However, No 570 Squadron's Mk IVs used the same flattened letter style, but in a lighter Roman font with regular character spacing. LK270, E7-W, has no invasion stripes but shows lingering signs of them on the rear fuselage around the crew entrance door and serial number.

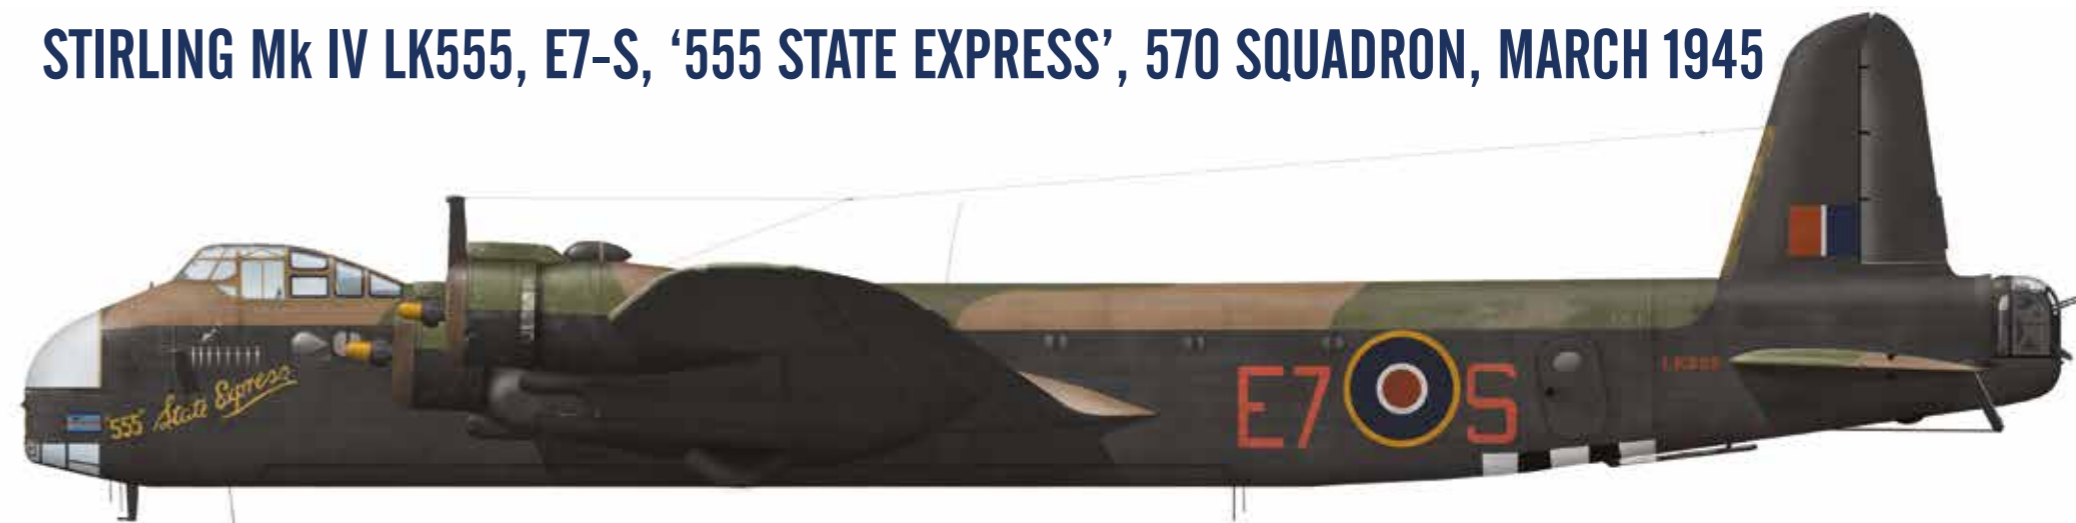
- Early style Perspex nose cap.
- Rebecca transmitter and receiver aerials.
- Single pitot tube mast.
- Longer Mk III/IV engine air intakes.
- Oil coolers under engine nacelles.
- Un-treaded smooth mainwheel tyres.
- Parachute strop guard and glider-towing bridle.

- Standard camouflage and national markings.
- Serial and thin lettering of squadron codes 'E7-S' in Dull Red placed lower down in relation to the roundel on the rear fuselage.
- Squadron code 'E7' and yellow propeller hubs denote 570 Squadron's B Flight.
- Squadron leader's 'class flag' motif on the nose, with horizontal stripes of dark blue/RAF blue/narrow red/RAF blue/dark blue. The RAF albatross is depicted in dark blue in the top left-hand corner of the upper RAF blue stripe.
- Nose art "555" in un-stylised numerals and 'State Express' in a curvy script (possibly in yellow).
- Ops log – 8 daggers, one glider (Arnhem),
- Invasion stripes prominent on underside of rear fuselage only.
- Partial overpainting in black of fuselage windows behind the wing.
- Worn paintwork on air intakes and engine cooling gills.
- Wheel chocks with aircraft's individual letter 'S'.

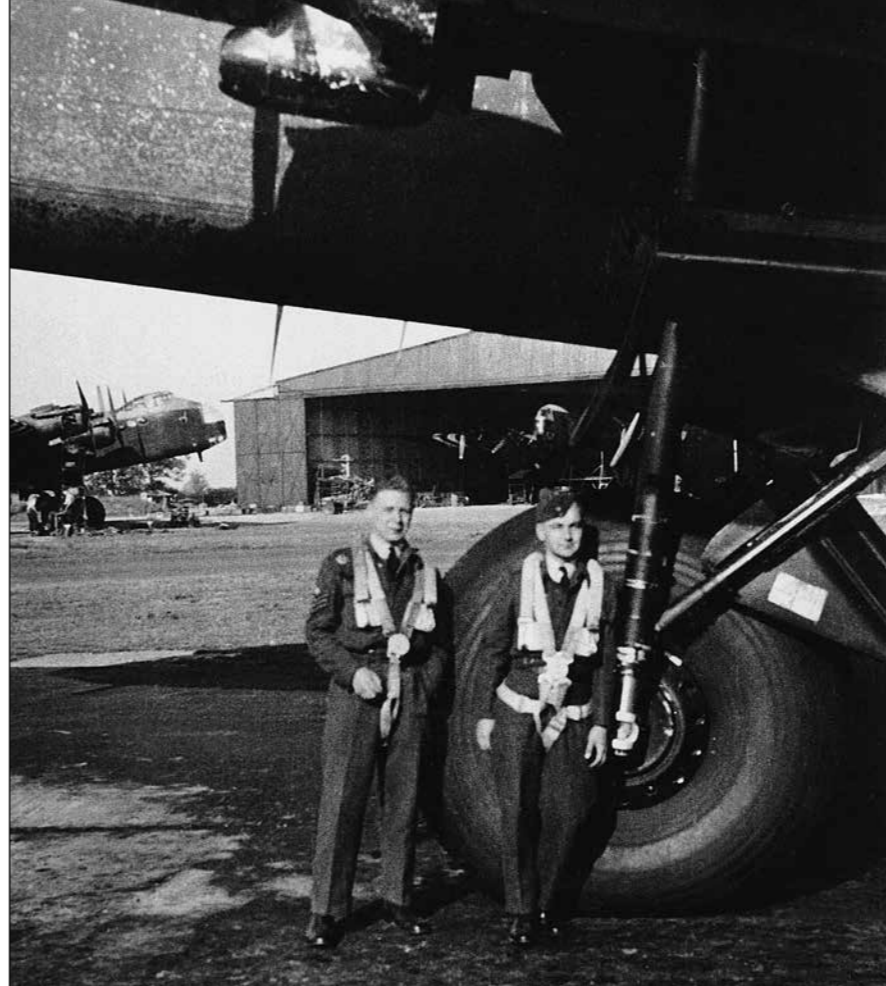
Right inset: With 161 Sqn pilot Stan Sicklemore for scale, the Stirling's slab-like tailfin was some 10ft high and 7ft 10in across its base, with an area of 77.4sq ft, while the rudder had a range of 22° 30' each way. Note the worn paint, three visible rudder hinges and Kilfrost anti-icing paste on the inner edge of the rudder. The pilot has placed his flying helmet and mask on the horizontal stabiliser in the foreground.

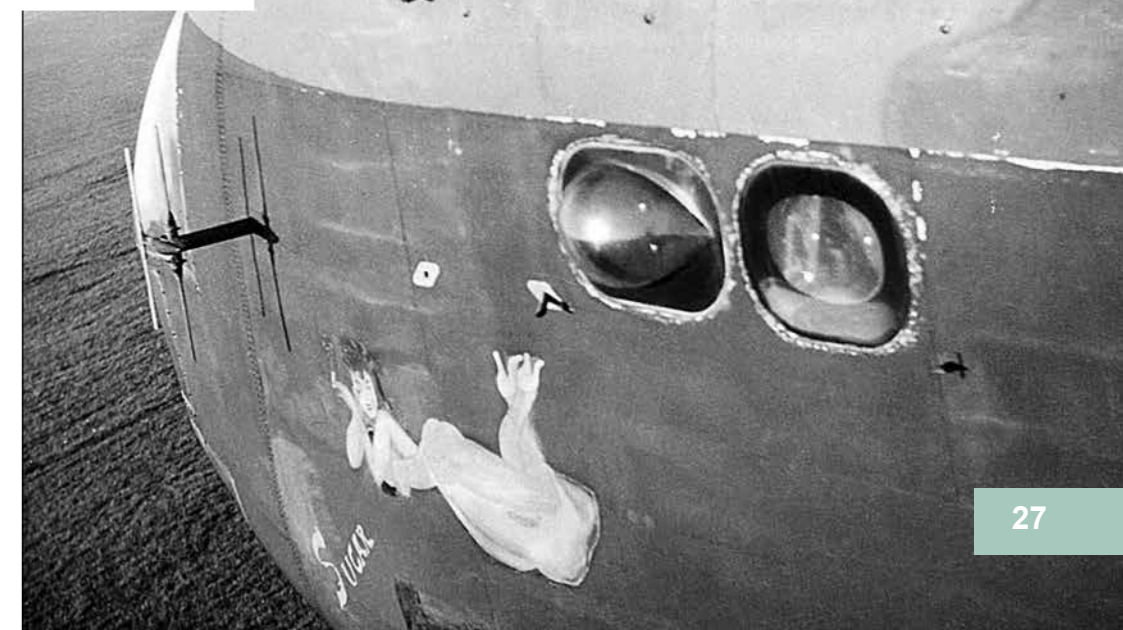
Below: The Stirling's impressive height above the ground could be readily appreciated from the cockpit, where the experience was akin to riding in the upstairs front seat of a double-deck bus. This 161 Squadron Stirling Mk IV named 'Sugar' with Stan Sicklemore in the pilot's seat, shows to advantage the cockpit coupé with sliding window at the pilot's position, blackout blinds inside the rear cockpit over the navigator's position, with black-painted edging to the windows to reduce any light spill from inside at night. The two windows in the fuselage below the cockpit are located opposite the navigator's chart table – the forward one has a convex observation blister while the second is flat and appears to be slightly recessed within a black fitting. The whip aerial on top of the coupé is believed to be the vertical antenna for Gee, while at lower left is the receiver aerial for Rebecca.

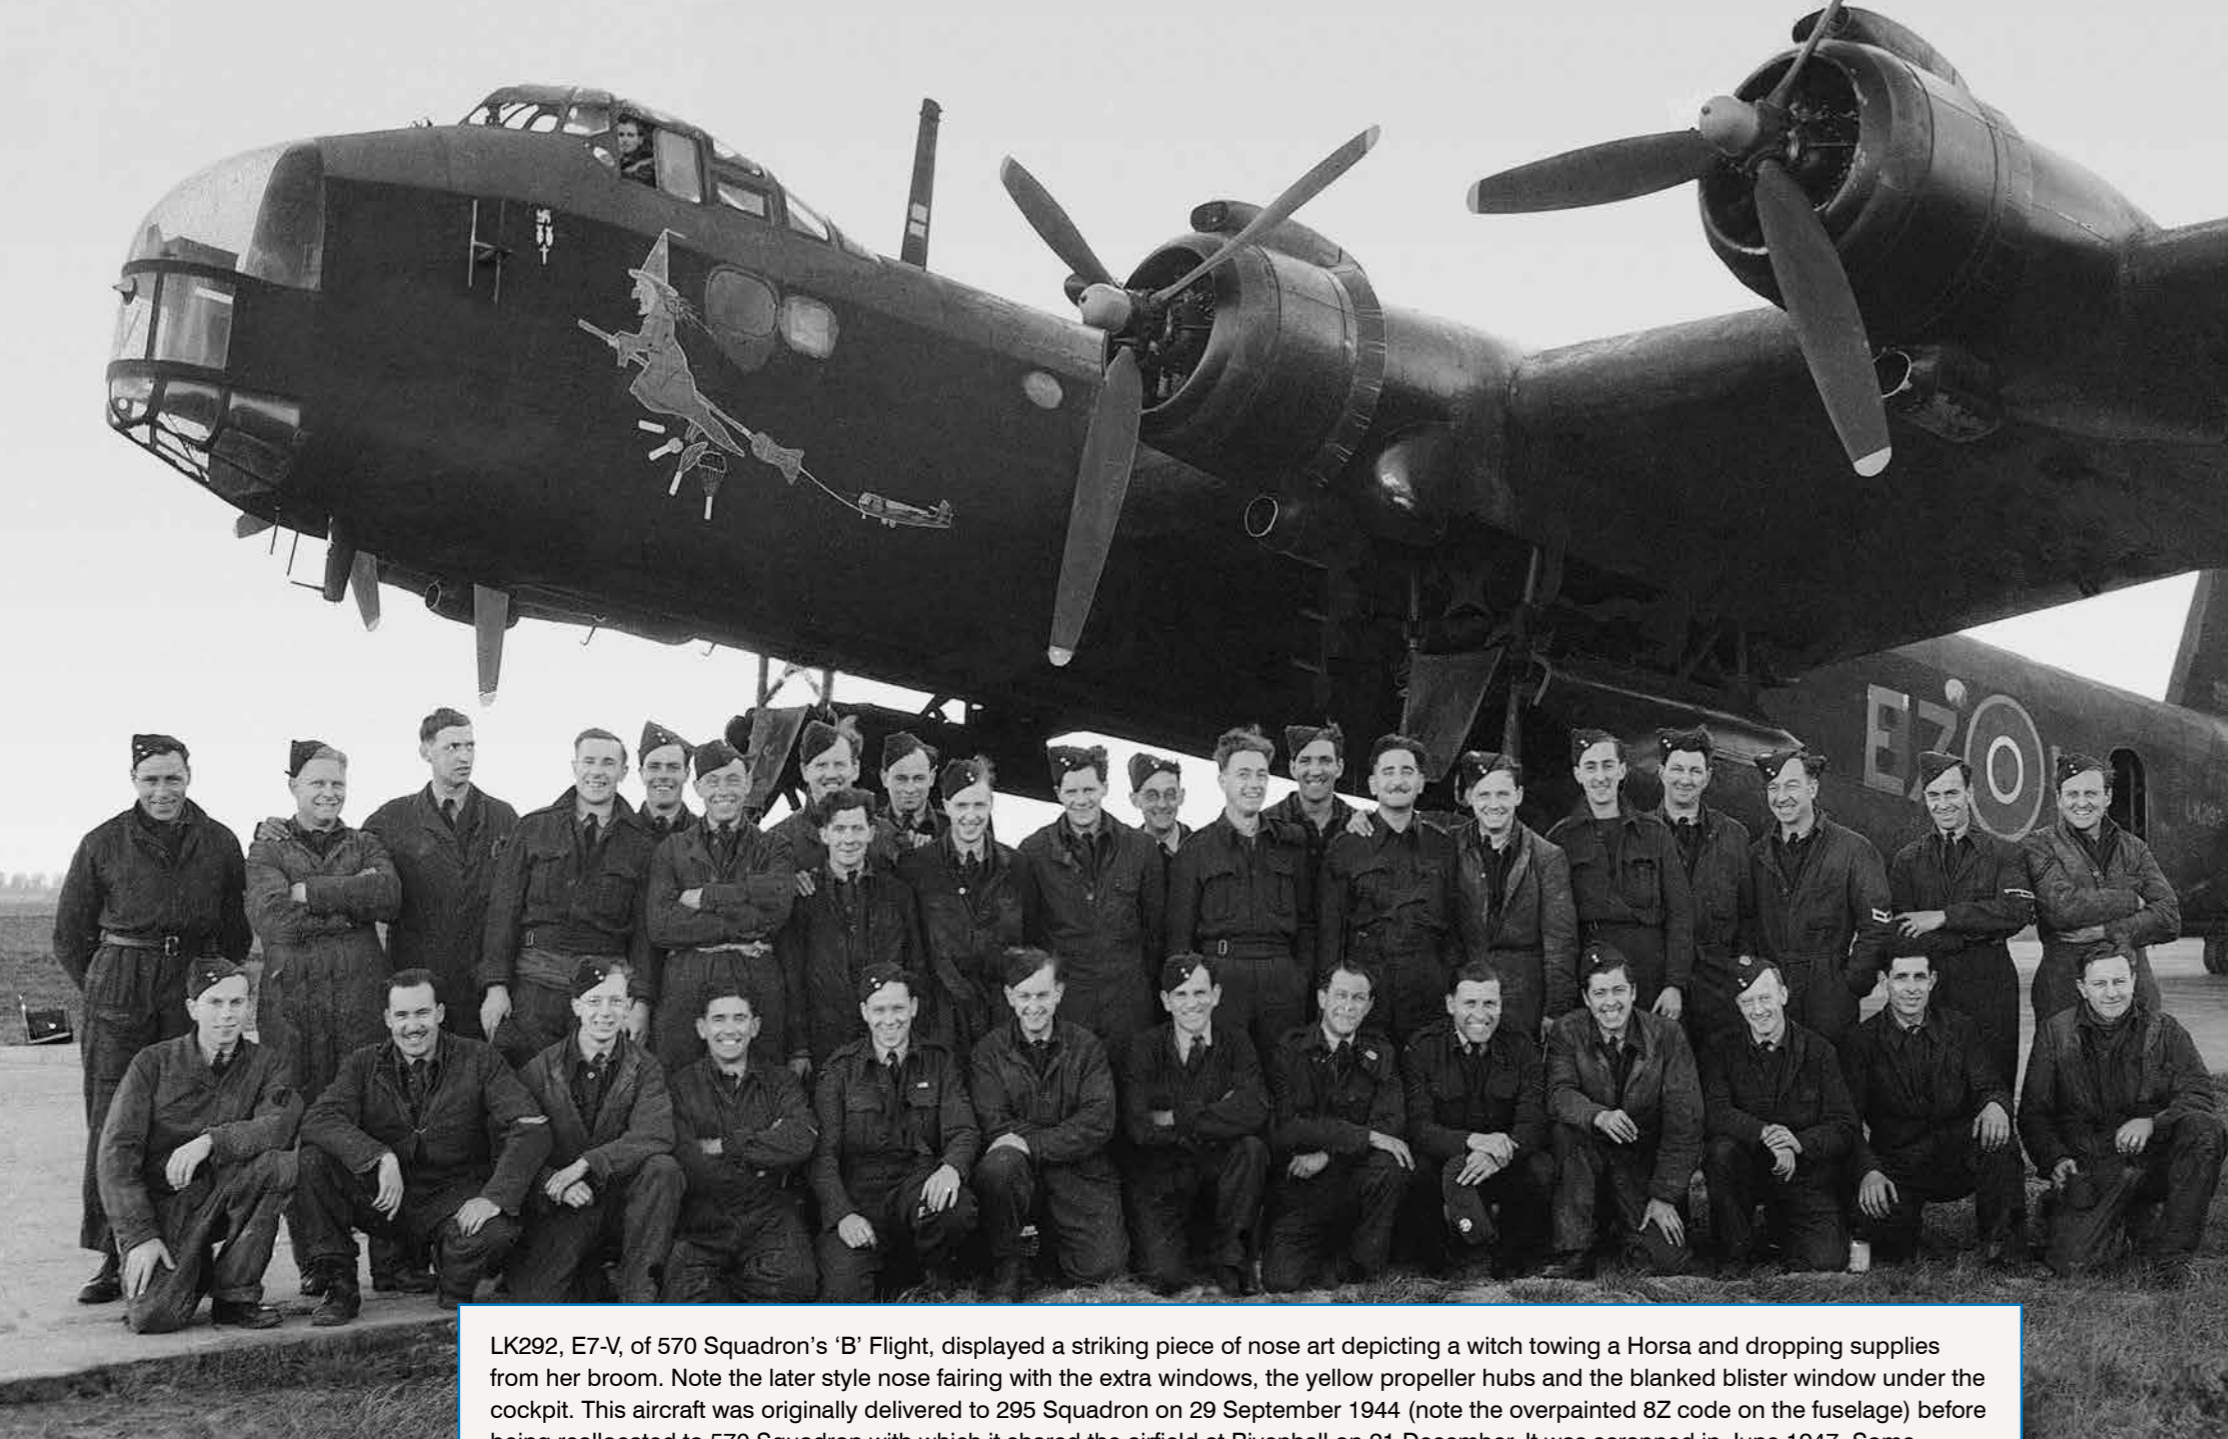
LK292, E7-V, of 570 Squadron's 'B' Flight, displayed a striking piece of nose art depicting a witch towing a Horsa and dropping supplies from her broom. Note the later style nose fairing with the extra windows, the yellow propeller hubs and the blanked blister window under the cockpit. This aircraft was originally delivered to 295 Squadron on 29 September 1944 (note the overpainted 8Z code on the fuselage) before being reallocated to 570 Squadron with which it shared the airfield at Rivenhall on 21 December. It was scrapped in June 1947. Some sources claim the code letter was W, which would tie in with the witch nose art, but official records show it as E7-V.

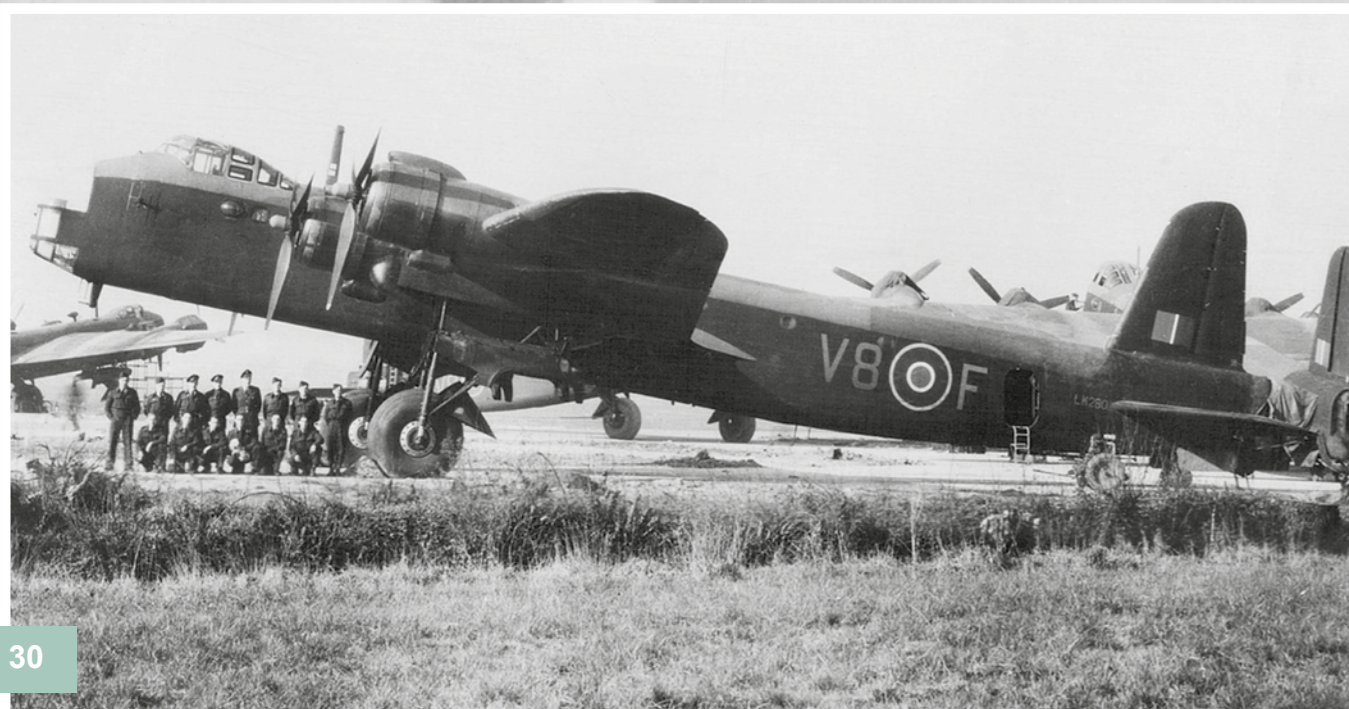
Left: LK280, an almost identical replacement V8-F, is seen at Rivenhall, Essex, in early 1945. Delivered to 570 Squadron on 23 September 1944, it flew a number of SD sorties as well as towing a Horsa on Operation Varsity (LZ 'P') on 24 March 1945, also flown by Flt Lt David Campbell. This later aircraft has the extra glazing in the nose, and red propeller spinners denoting a B Flight aircraft.

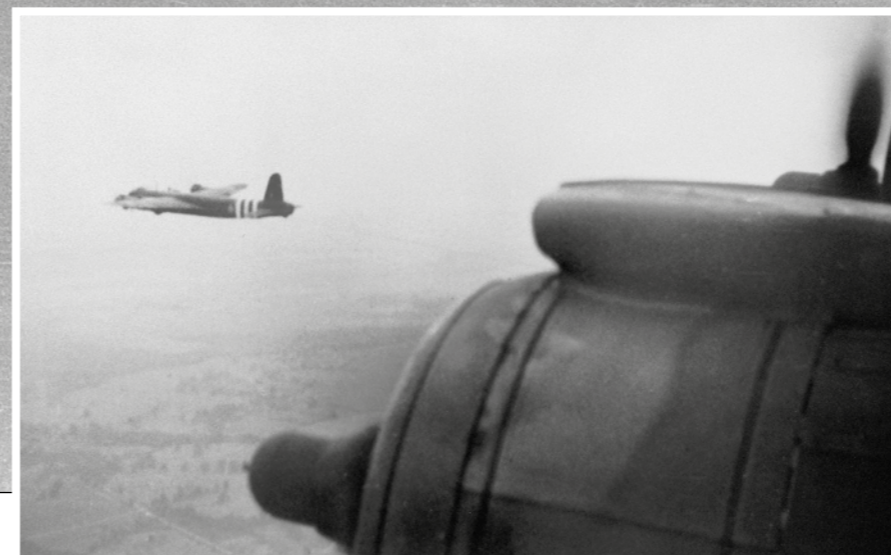
PARACHUTE STROP GUARD

Right: A 6ft x 4ft hatch was installed in the fuselage floor for paratrooper and supply dropping. A retractable tubular metal frame strop guard (or 'gate') was mounted underneath the rear fuselage behind the hatch, which was lowered and held in place by a strut and pin, its purpose being to trap the parachute static lines and prevent them from being whipped up by the slipstream and into the tailplane, causing damage. Once all the paratroopers had jumped, the static lines could be winched back on board by the despatchers using a pair of winches attached to the fuselage floor, and the guard retracted manually using a raising/lowering arm in the floor that passed through a hole in the under surface of the tail section just forward of the horizontal stabiliser front spar frame.

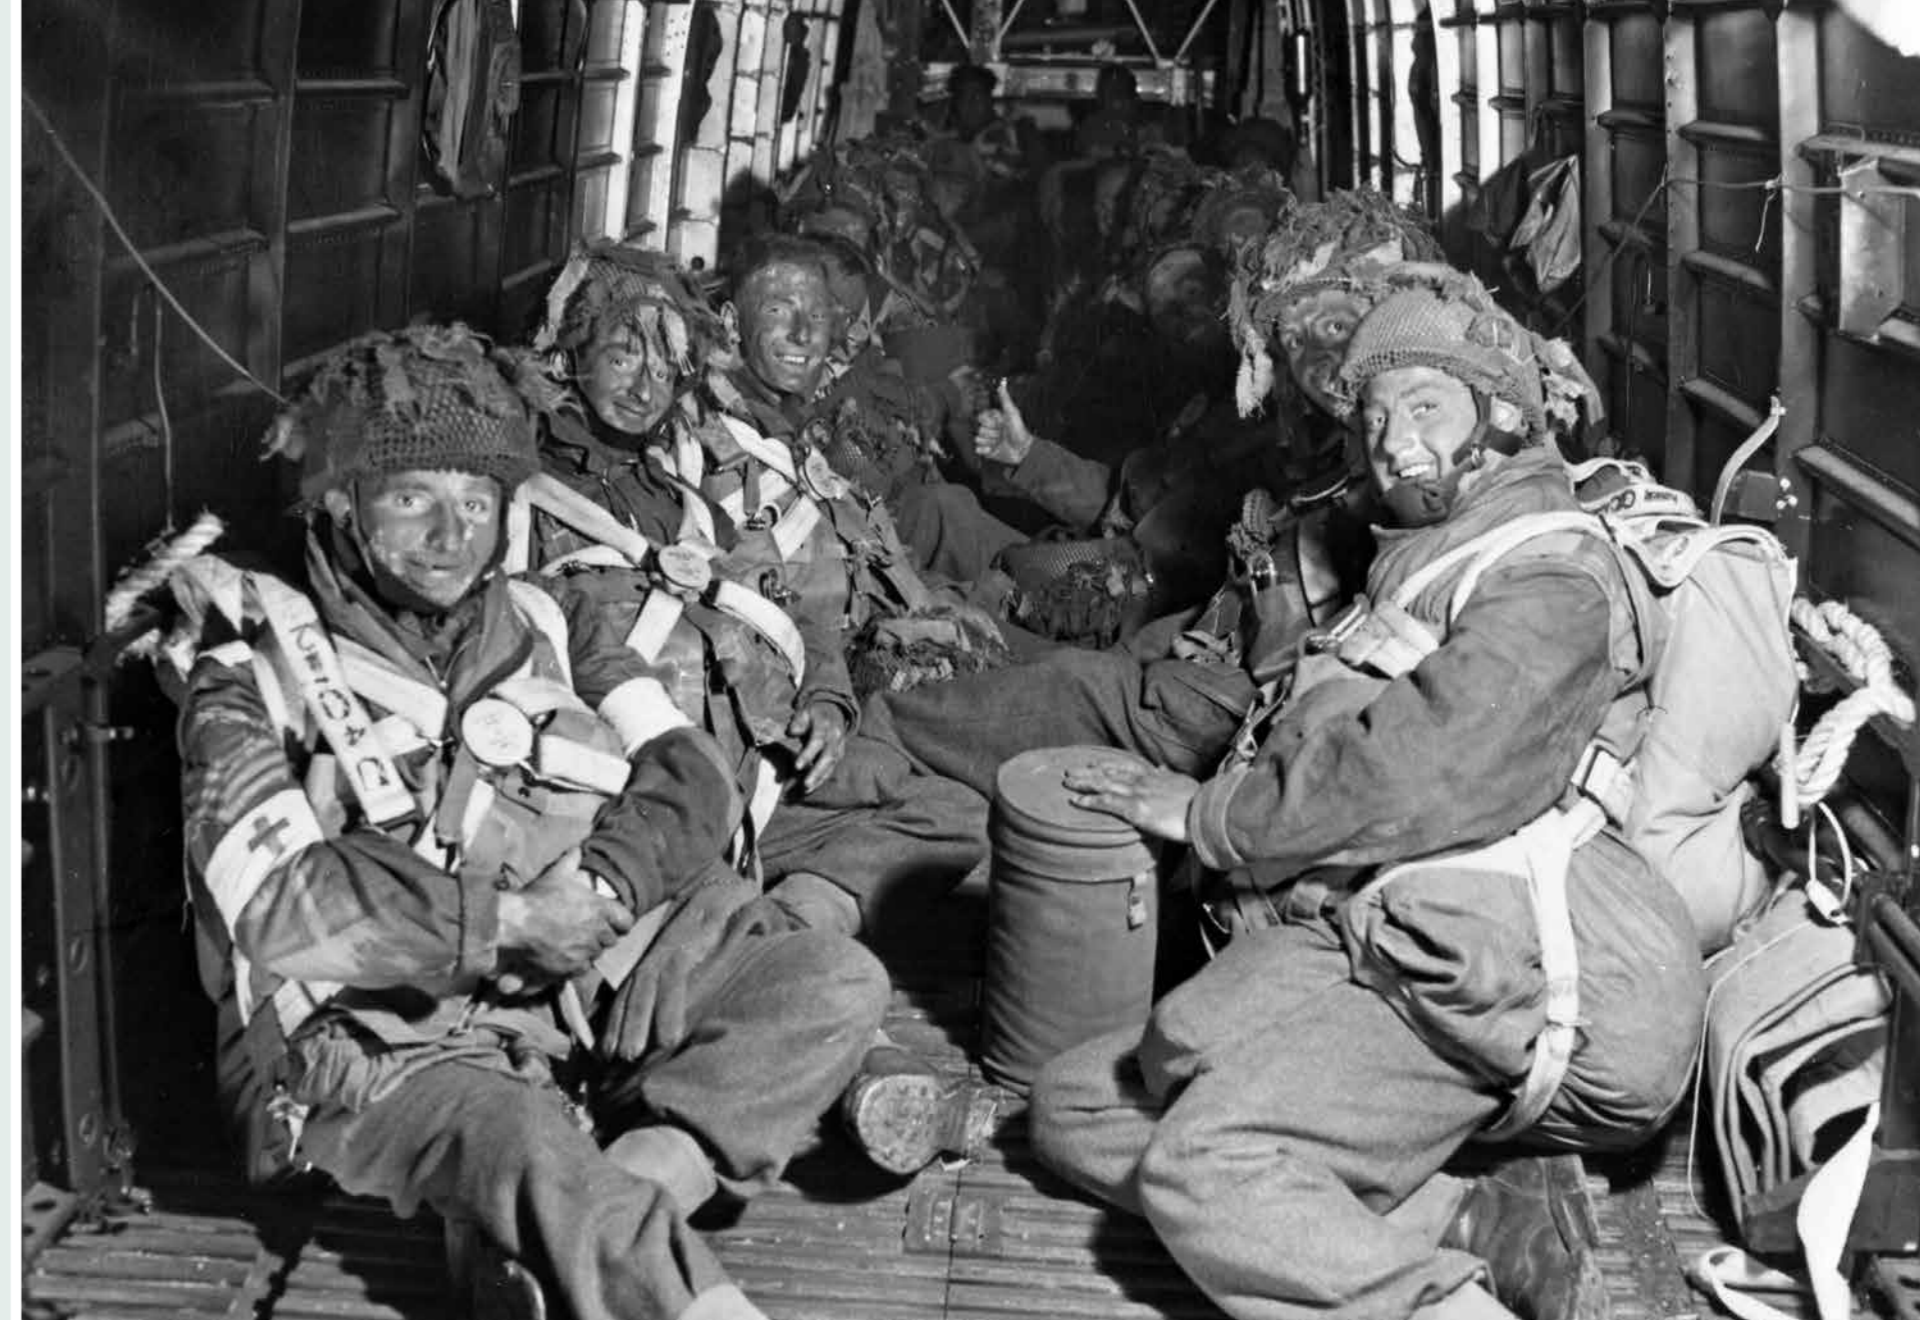
Twenty fully kitted paratroopers with chutes and more than 60lb of equipment each sit on the floor of a Mk IV as they are flown to their DZ in Normandy on 5/6 June 1944. The men are wearing Oversmock jump suits over their Denison Smocks, and Type X Mk II parachutes. In this view looking forward, in the foreground can be seen the wooden door over the paratroop exit that also formed part of the fuselage floor. The paratroop exit had two doors – one in the floor and the other in the fuselage skin under the fuselage. The top (wooden) door was opened by undoing two fasteners, folding the port half onto the starboard half, and then both halves over to starboard; the bottom (aluminium) door was released by undoing five spring-loaded bolts and then opening inwards.
