# REAR TURRET

## HALIFAX L9530 MP-L, 76 SQUADRON, JUNE 1941, MIDDLETON ST GEORGE

## Mk.I SERIES 2

# GALLAY RADIATORS AND COWLINGS

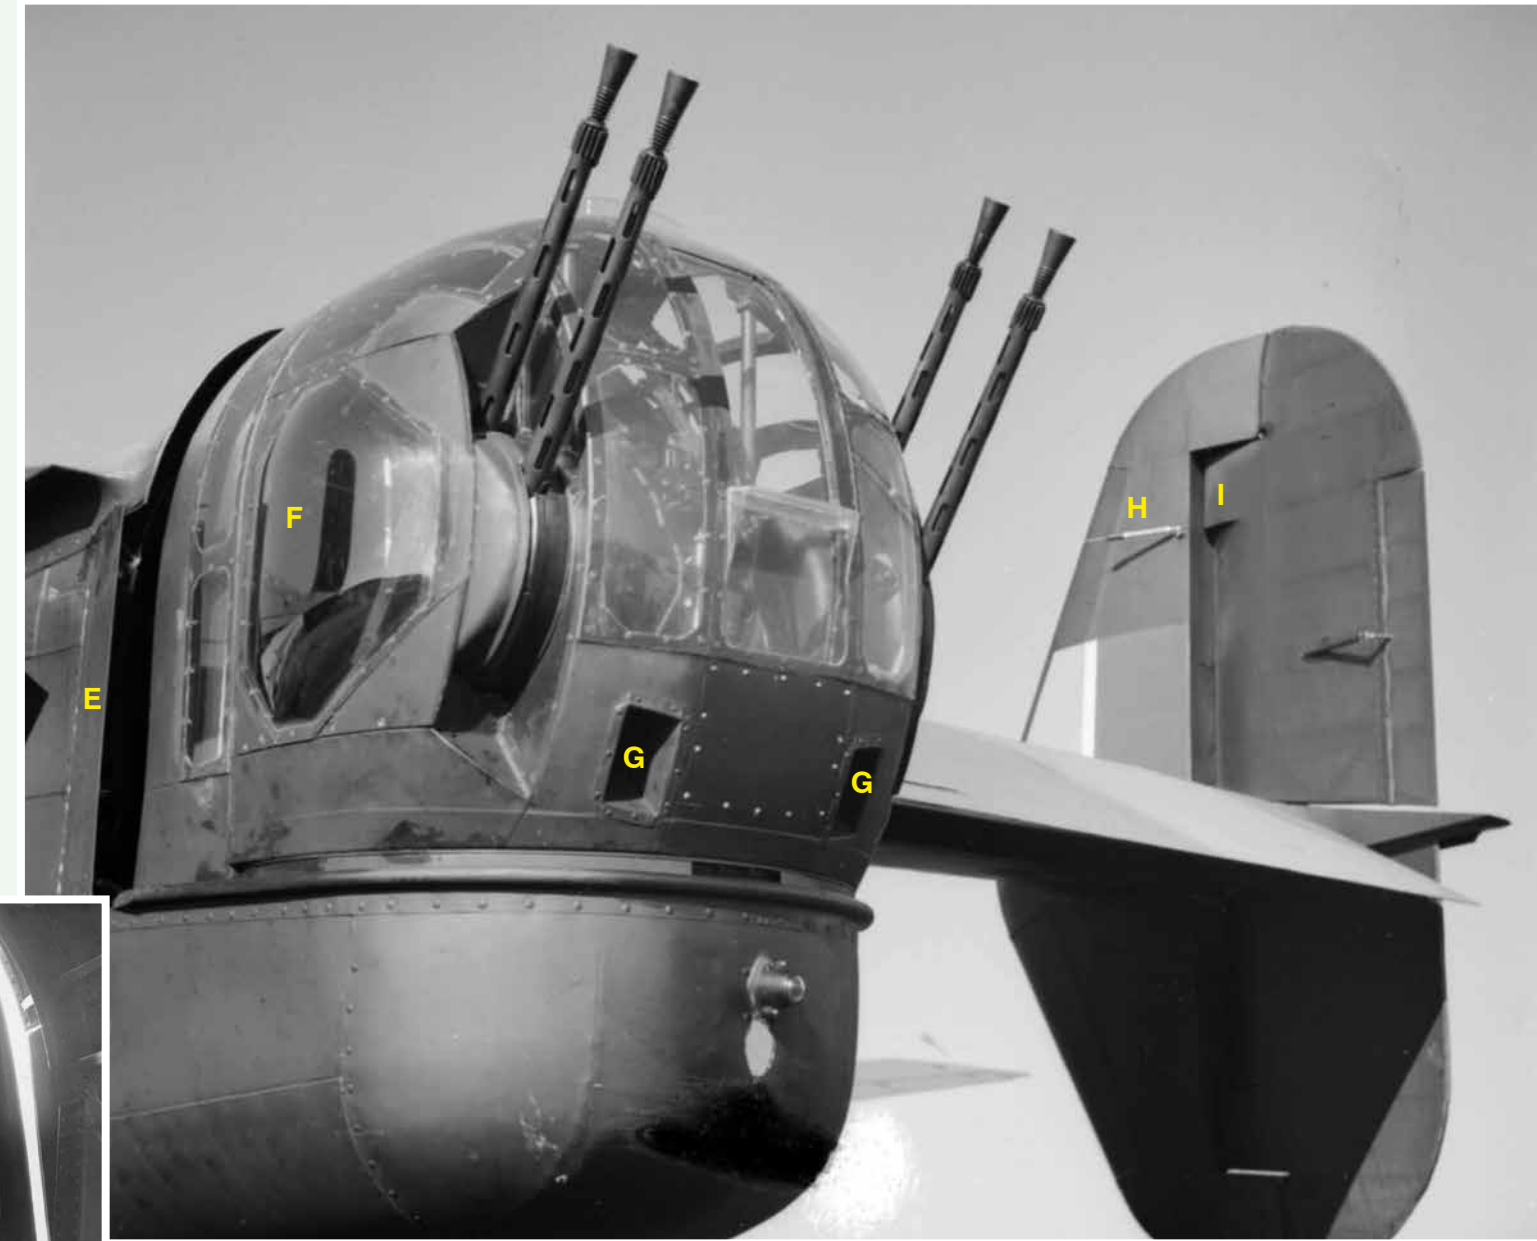
Right: Noteworthy items in this view of a Type E rear turret on a 78 Squadron Mk.II are the 'Jicwood' compressed wood turret balance flaps (E), gun breech bulged Perspex fairings (F), spent case and link ejection ports (G) and the starboard main fixed aerial aft attachment tensioning spring unit (H). Bulbous nose rudders (I) were one of the modifications introduced as a result of the Halifax's rudder overbalance trials and will be covered in Volume 2.

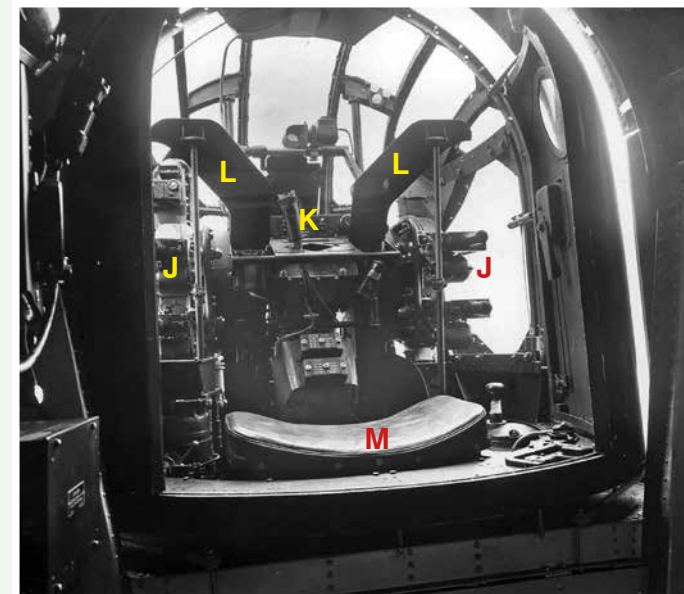
Below: Boulton Paul signature features visible include the breeches of the horizontally-mounted guns (J), control column (K) and adjustable arm rests (L). Unusually, when the guns were depressed, hydraulic rams elevated the seat (M) to help the gunner's aim. Ammunition feed problems weren't fully eliminated until an electric servo assister was developed in late 1941, the A&AEE alone expending over 34,000 rounds in search of a cure!

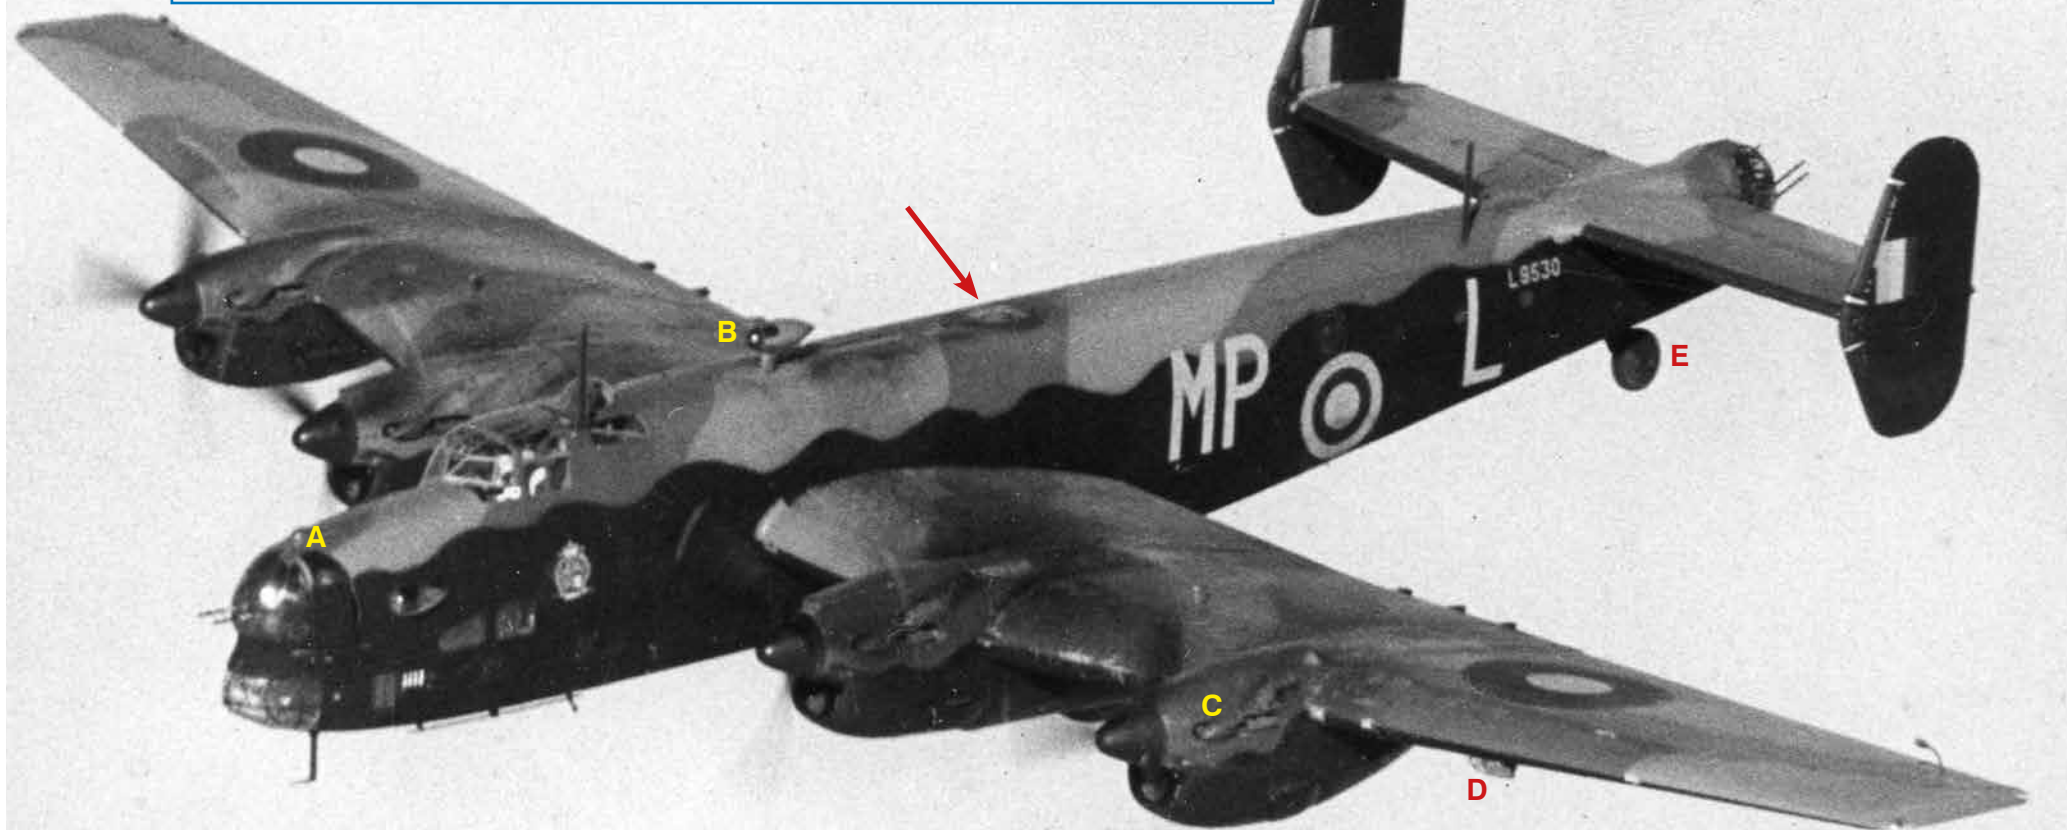
The four bomb tally on 76 Squadron's L9530 indicates this photograph was taken on or soon after 3 August 1941. The single Perspex escape hatch (arrowed) was another feature introduced on the Mk.I Series 1, the forward aerial mast being of a slightly wider section on L9530 and subsequent airframes due to the addition of a de-icing boot. Other points of interest include the large fairing (A) over the front turret's electrical distributor and oxygen inlet, paint partially stripped from the D/F loop fairing (B) revealing the shiny, dark brown Bakelite beneath, original non-flame damping manifolds (C), dipped landing lights (D) and fixed tailwheel (E). The 'A' pattern Dark Earth/Dark Green camouflage features a medium height demarcation line with very widely spaced waves, with RMD 2A Special Night lower surfaces and light grey fuselage codes.

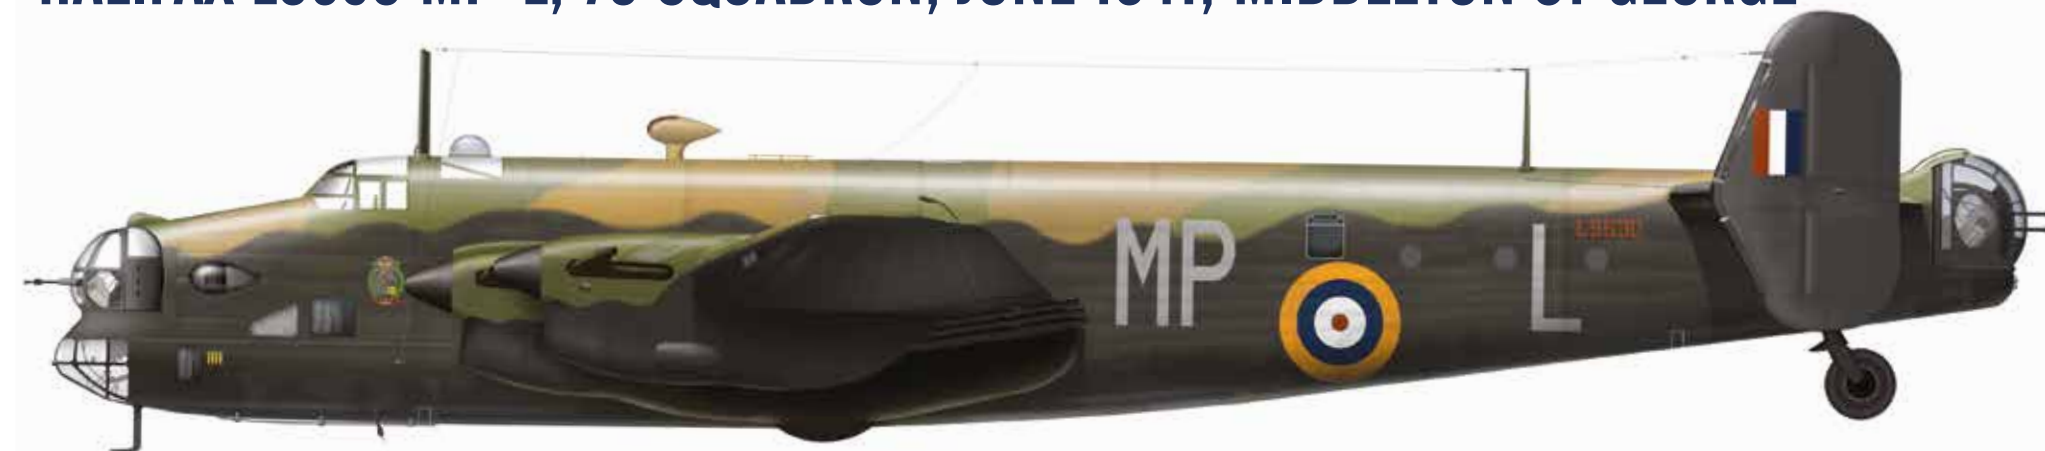
### Modeller's notes

Delivered to 76 Squadron June 1941

- Type A camouflage pattern with mid-height widely spaced wavy demarcation line and RMD 2A Special Night lower surfaces
- Early type fuselage roundel and fin flash, grey fuselage codes and dull red serial number
- Black front and rear turret framing
- Beam gun positions but no mid-upper turret
- Two aerial masts
- Deicing boots on tailplanes and fins
- Fuel jettison pipes
- Faired D/F loop
- SBA dipole aerial
- Trailing aerial fairing
- Large carburettor intakes without ice guards
- Original type non-flame damping exhausts
- Barrage balloon cable cutters
- Single dorsal escape hatch and long fuselage handrail
- Early type wingtip formation lights inside Perspex covers
- Tail formation light
- Mass balances above ailerons
- Fixed tailwheel

Shot down 13 August 1941

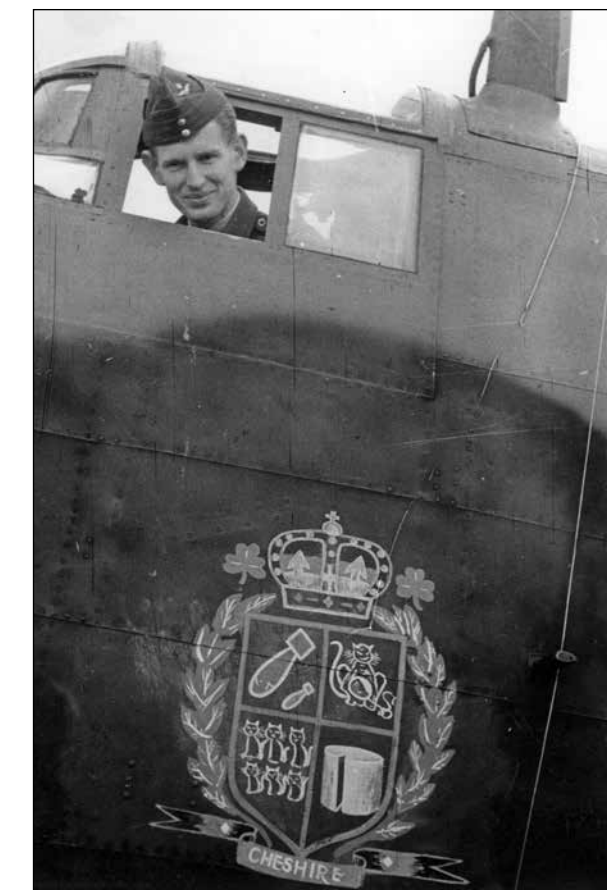
Right: Seen with regular skipper F/O Christopher Cheshire, L9530's nose art featured a 'family crest' complete with grinning Cheshire cats and a large wheel of Cheshire cheese.

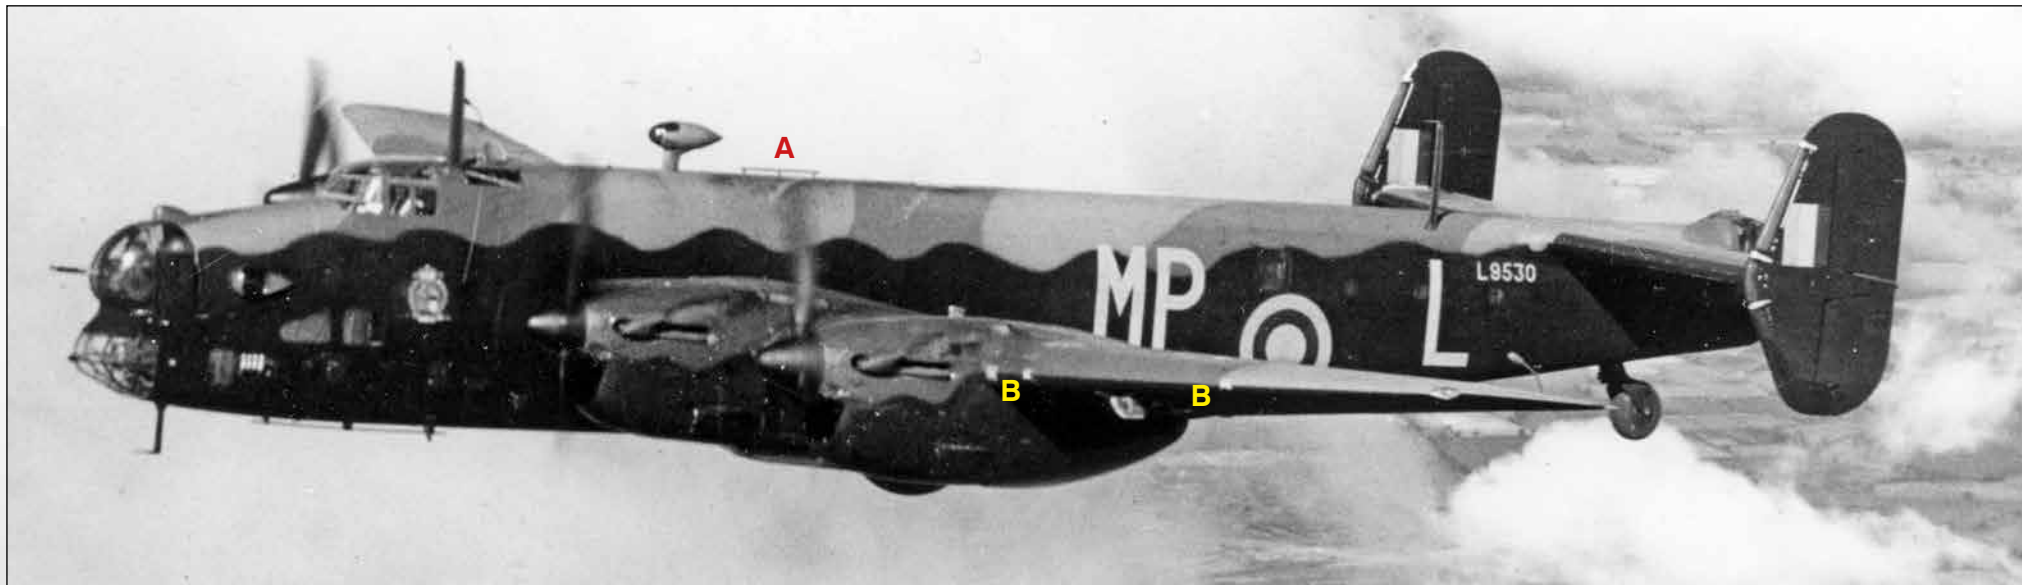
Top: The handrail (A) aft of the D/F loop was another feature introduced on the Mk.I. Also fitted to early Mk.II and V aircraft, a shorter rail was frequently fitted on later production machines when a second dorsal escape hatch was added. Although leading edge slats continued to be installed on early production aircraft, their negligible effect on performance coupled with concerns over asymmetric operation caused by barrage balloon cable damage led to them being locked shut, an armoured leading edge and Martin Patent cable cutters (B) eventually being fitted instead.

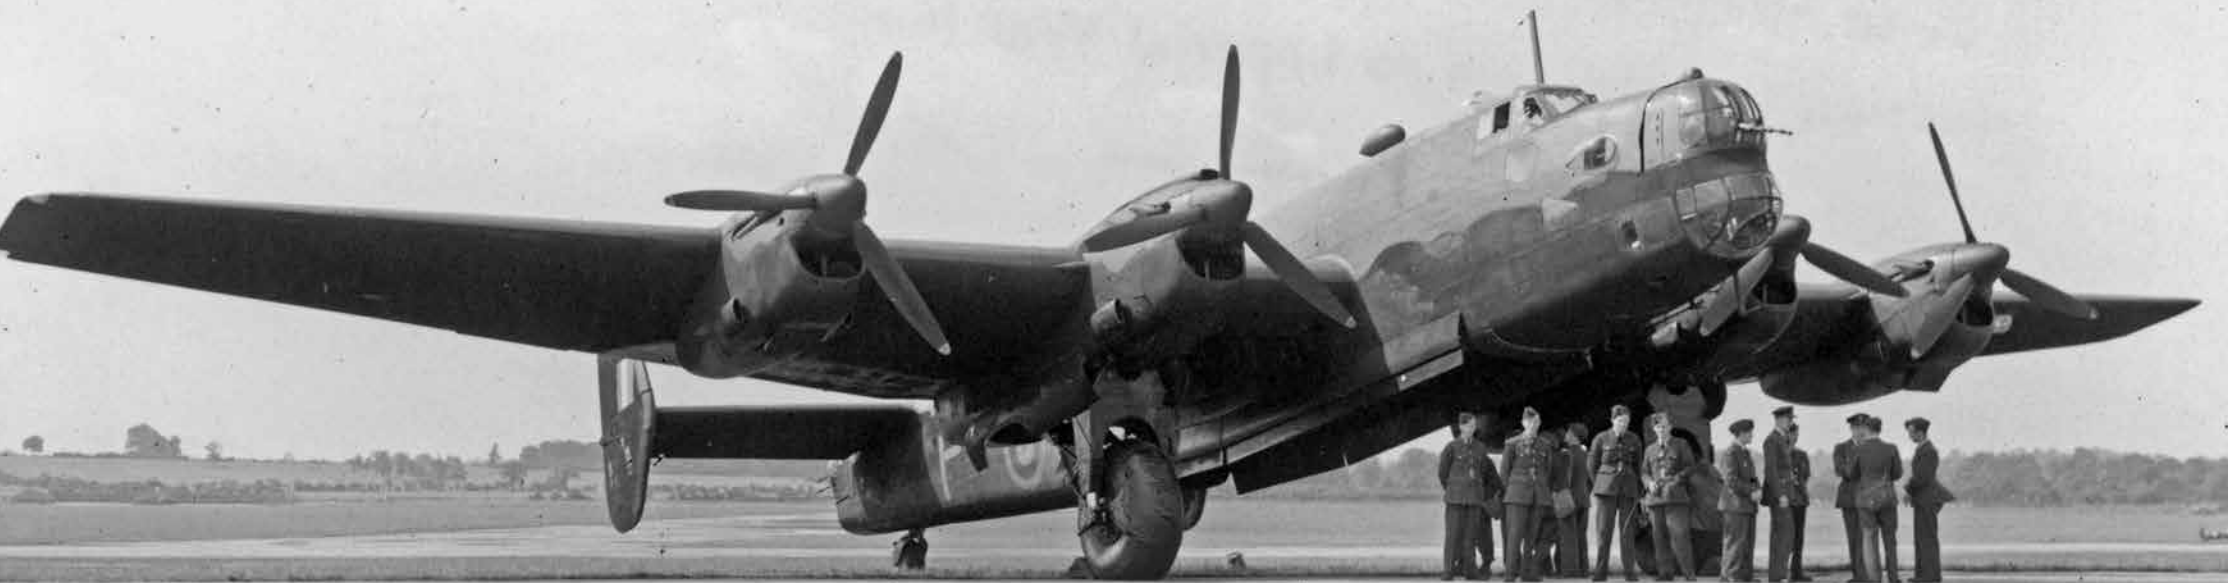
Above: On 21 July 1941, examples of the RAF's new heavy bombers were flown to RAF Northolt for inspection by Winston Churchill, L9503 TL-P of 35 Squadron being chosen to represent the Halifax. Visible in this view are the slightly forward raked, original shape radiator cowlings with twin Gallay coolant radiators visible within. Unusually the aircraft does not have fuel jettison pipes.

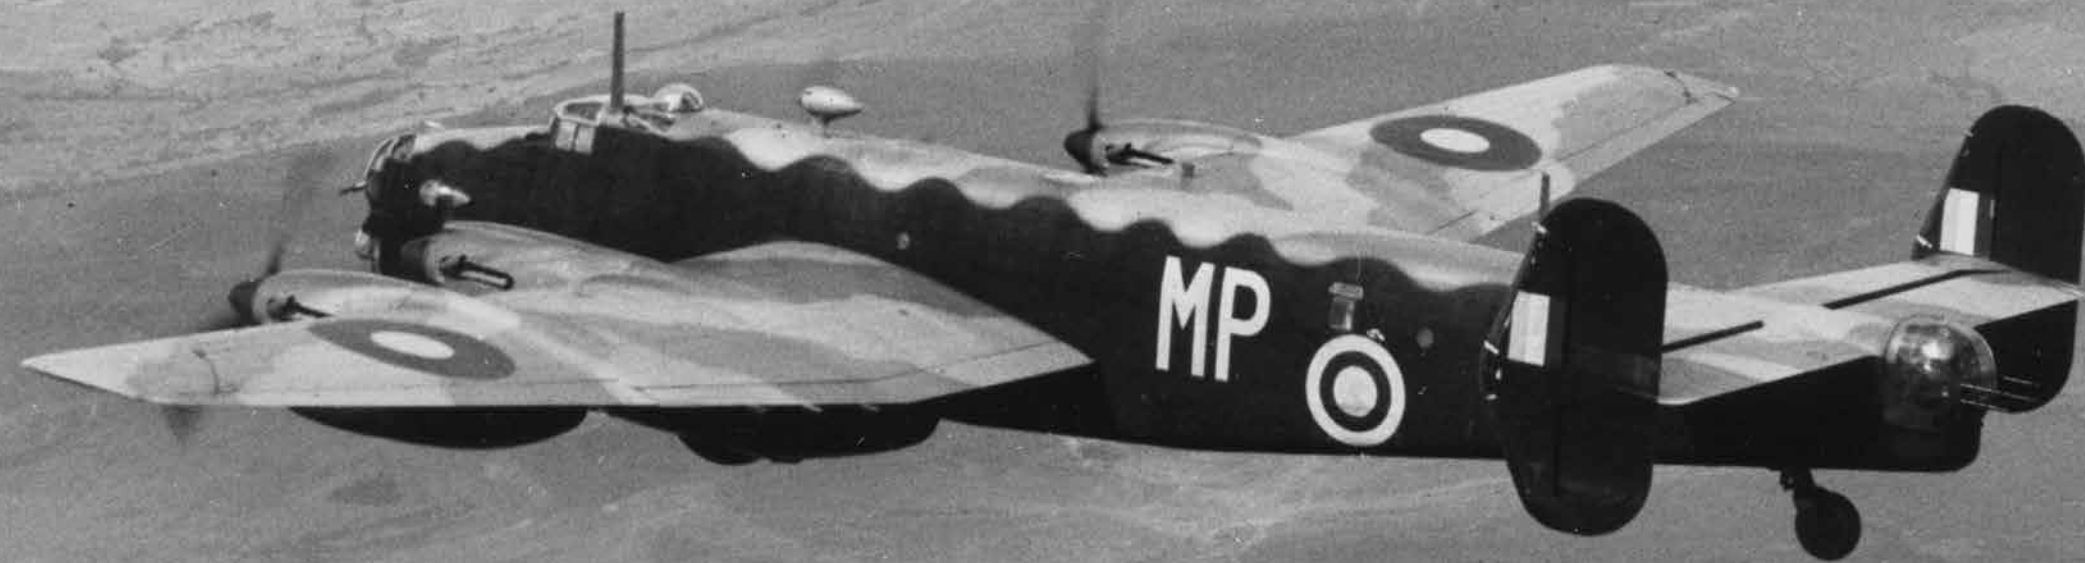
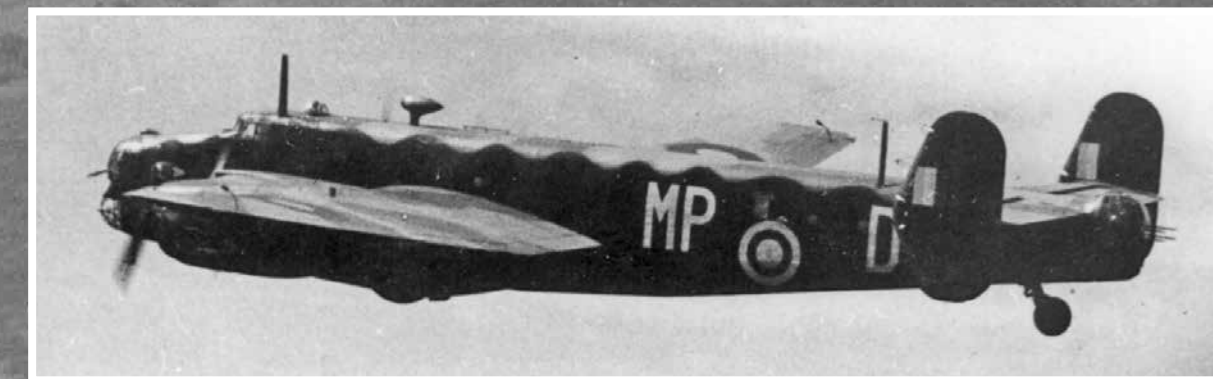
Although these photograph dates from exactly the same time period as the image on page 20, 76 Squadron Mk.I Series 2 L9562 features a much higher fuselage demarcation line than L9530. Mk.I Series 2 aircraft had an increased maximum weight and other detail changes, however externally they were indistinguishable from Series 1 aircraft. These images were taken on 6 August 1941, L9562 being flown by 76 Squadron's 'A' Flight Commander S/L R Bickford.

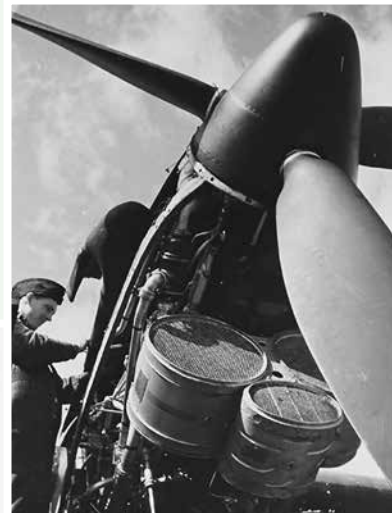
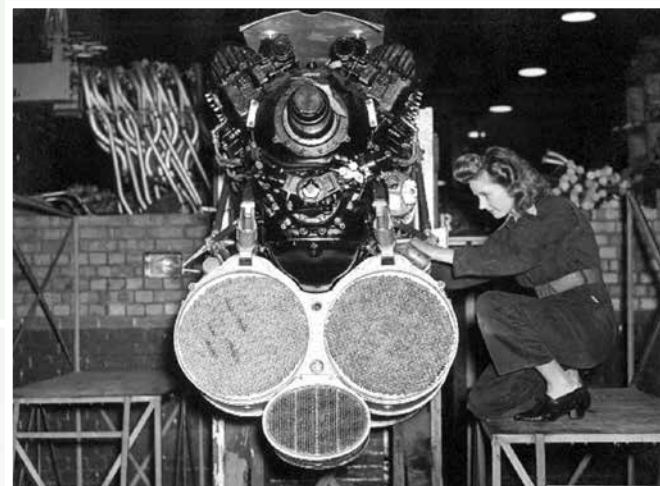
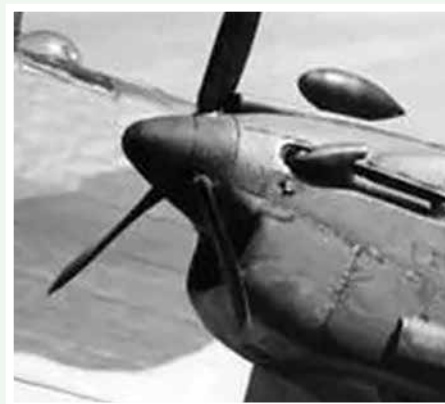
Top left, middle and right: All Halifax Merlin powerplants prior to the introduction of the Mk.II and Mk.V Series 1A had twin Gallay coolant radiators with single oval-shaped underslung Gallay oil coolers. The Gallay units were quite large and consequently also required rather bulky engine cowlings, the bottom edge of the radiator inlets featuring a noticeable forward rake.

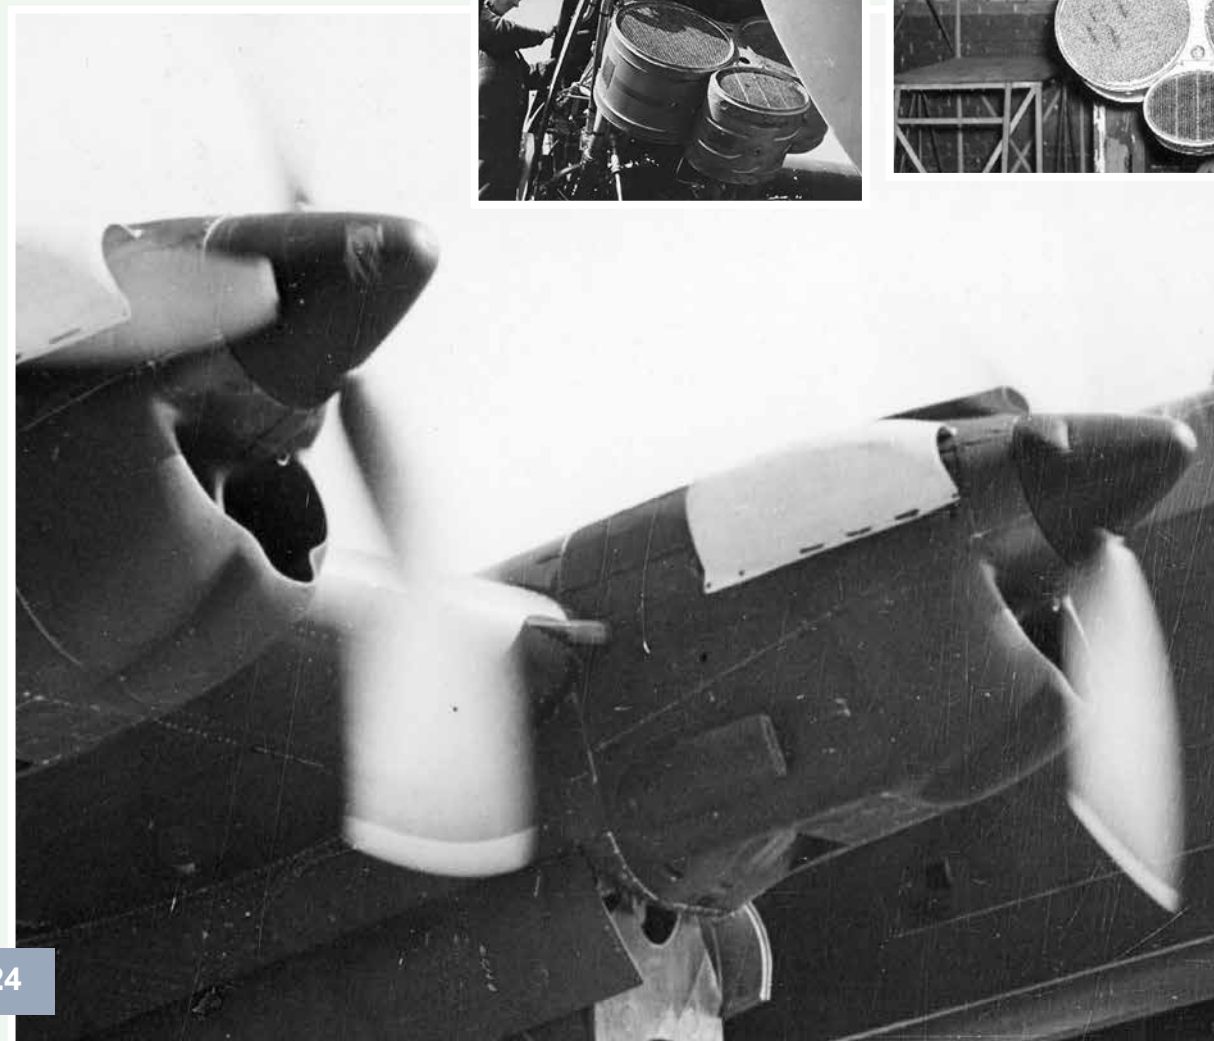
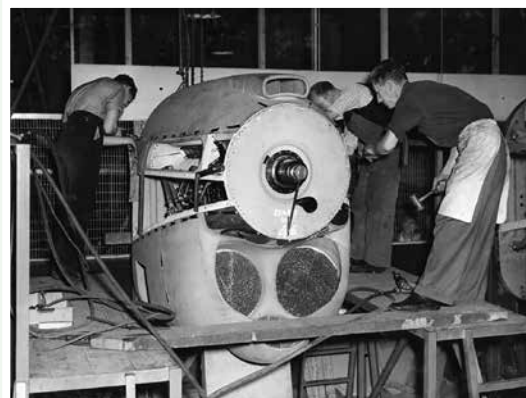
Left and above: Although retaining Merlin X engines the Mk.I Series 3 introduced modified cowlings featuring a more rounded radiator inlet with the addition of a distinctive bulged fairing which wrapped tightly around the oil cooler, the revised shape being carried over to the Merlin XX powered Mk.II and V Series 1s.

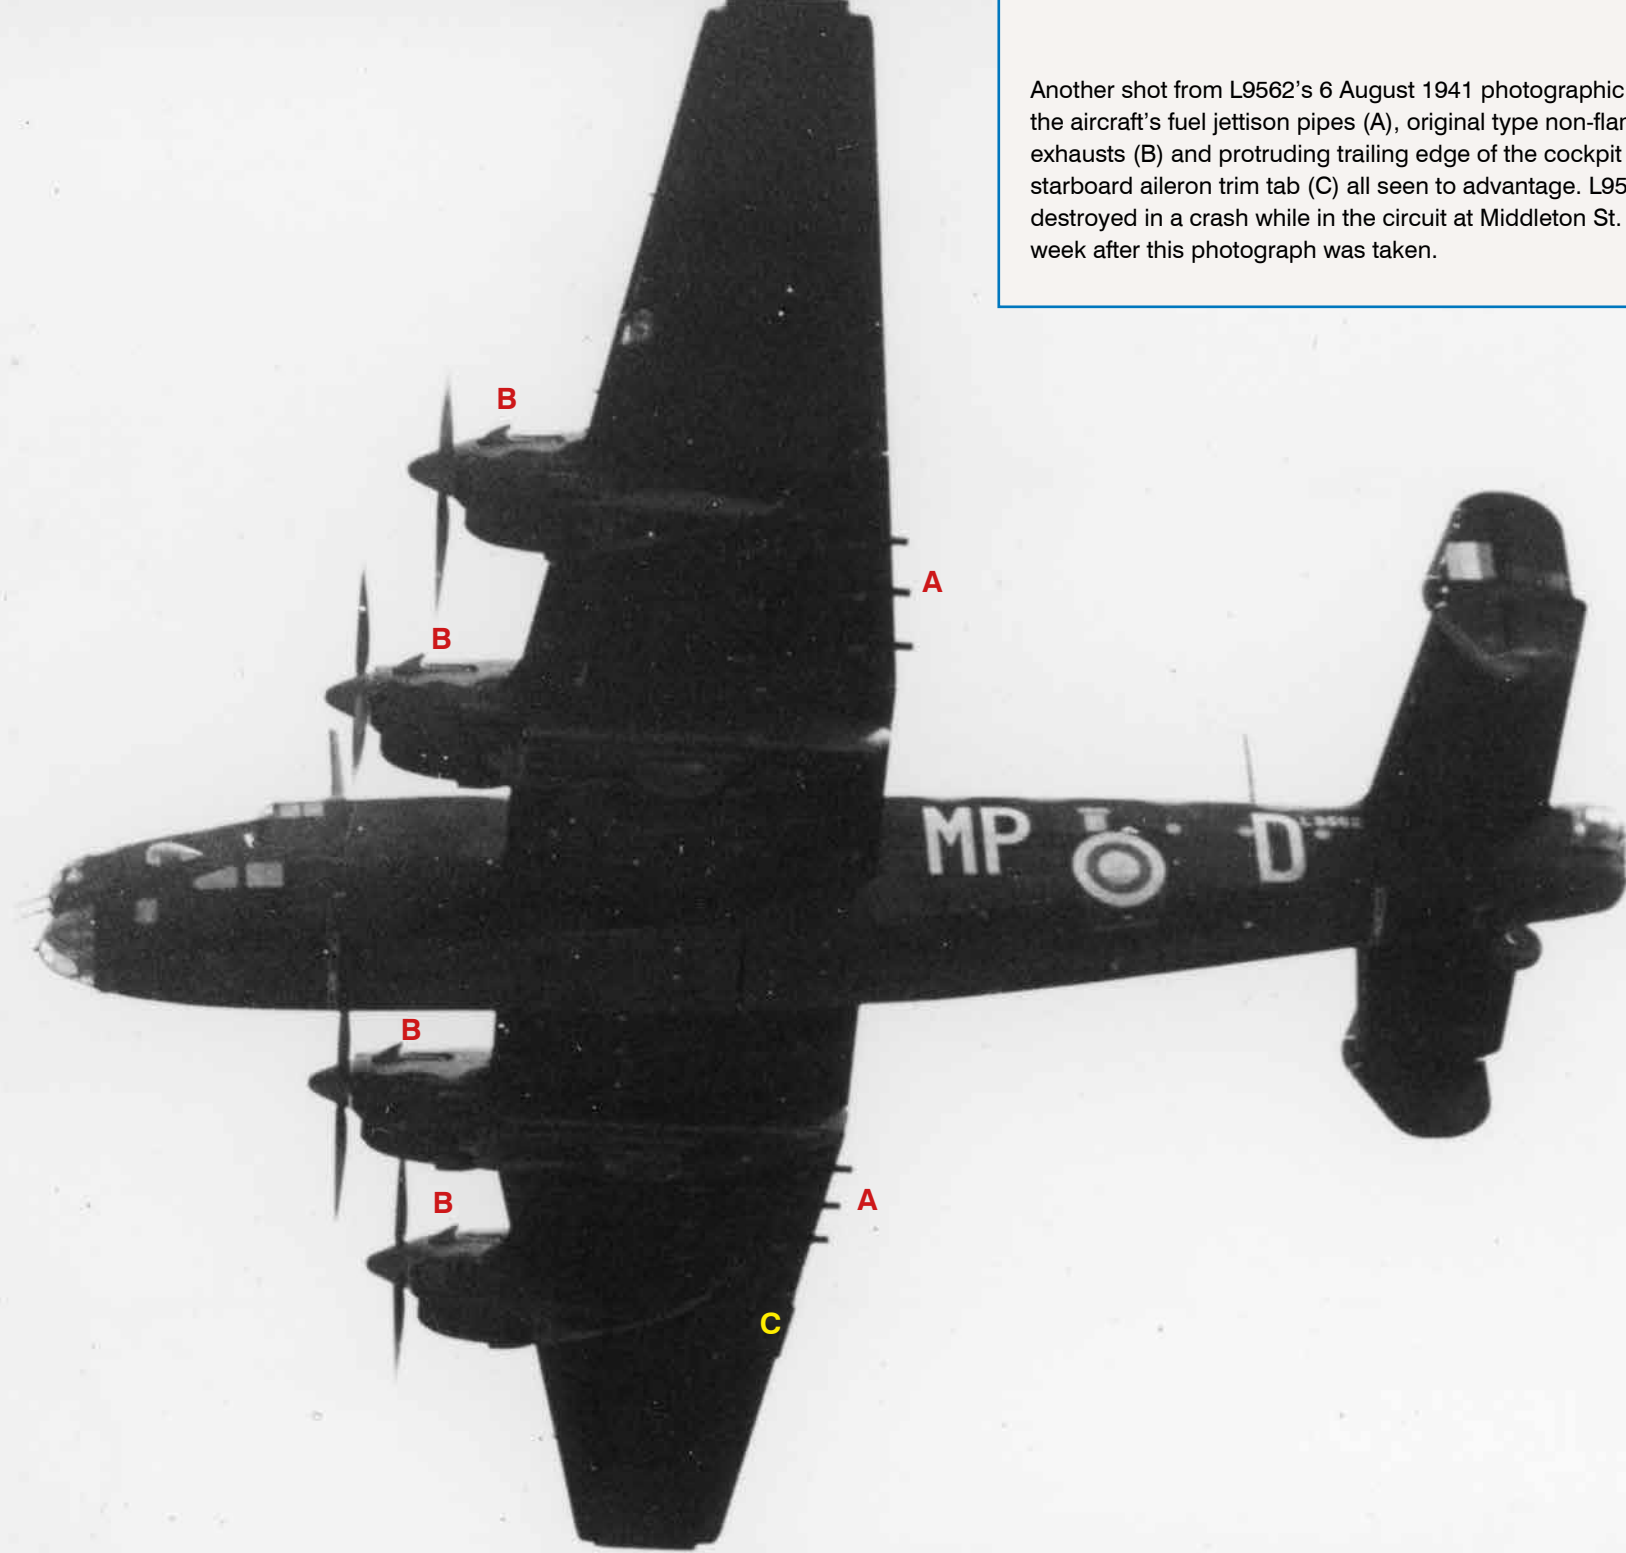
Another shot from L9562's 6 August 1941 photographic session, with the aircraft's fuel jettison pipes (A), original type non-flame damping exhausts (B) and protruding trailing edge of the cockpit adjustable starboard aileron trim tab (C) all seen to advantage. L9562 was destroyed in a crash while in the circuit at Middleton St. George just a week after this photograph was taken.
