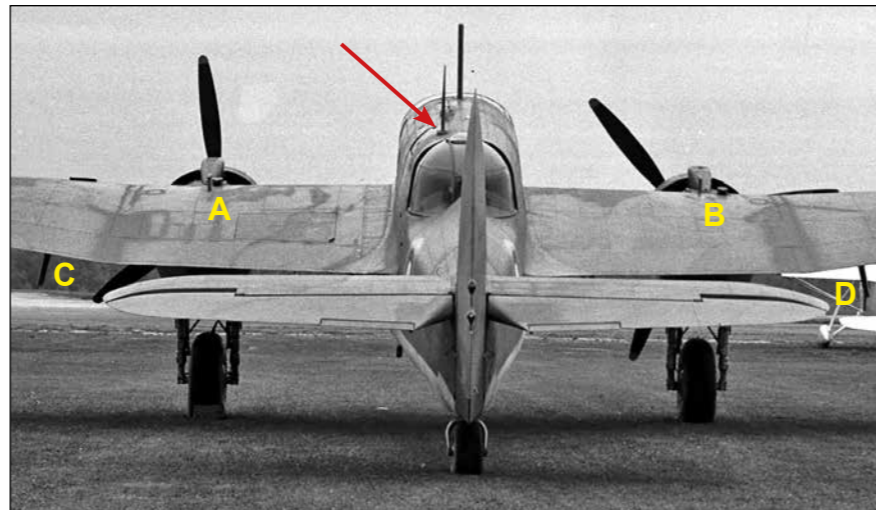
Right: Early Beaufort N1007 shows how the main aerial mast was mounted centrally on top of the fuselage, but the DF loop was slightly offset to port. The extra aerial (arrowed) just forward of the rear turret was offset further still to port and angled backwards. Note the asymmetrical vents (A) and (B) behind each engine. Also worth noting is the fuel jettison pipes (C) and (D) were not mounted vertically but were angled outwards with the wing dihedral.

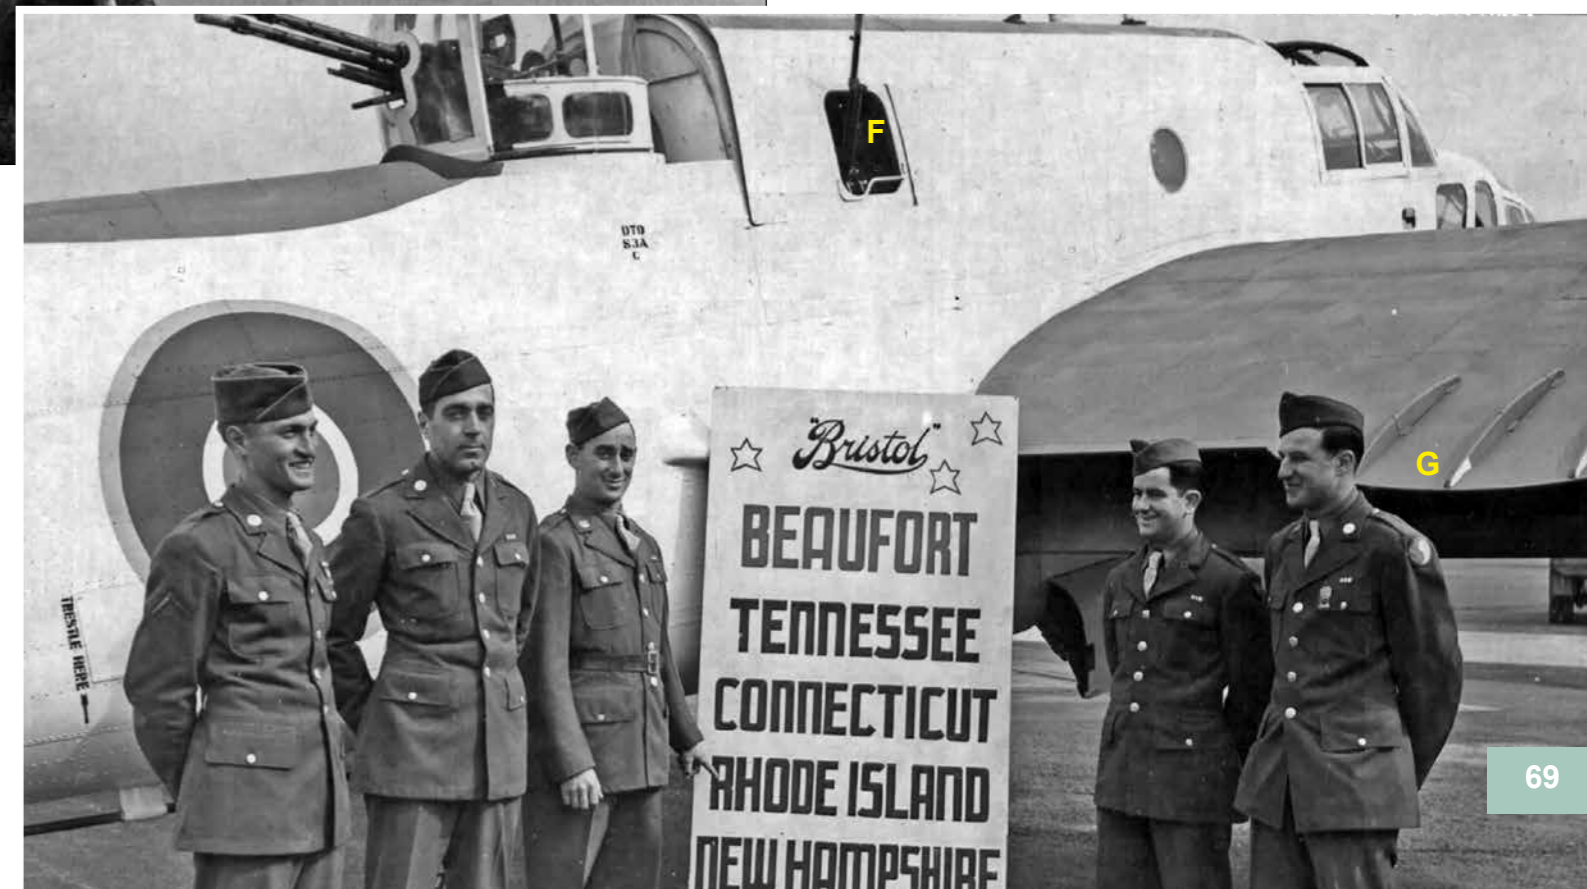
Below: A factory fresh Beaufort Mk.IA is shown in a naming ceremony alongside US personnel in early 1944. The DTD and Trestle stenciling appears to be in black. The starboard hatch (F) is open and a machine gun is mounted in position. The light coloured line at the bottom of the hatch is the metal guard to stop the gunner shooting at his own wing. The white paint is visible again on the strakes at (G).

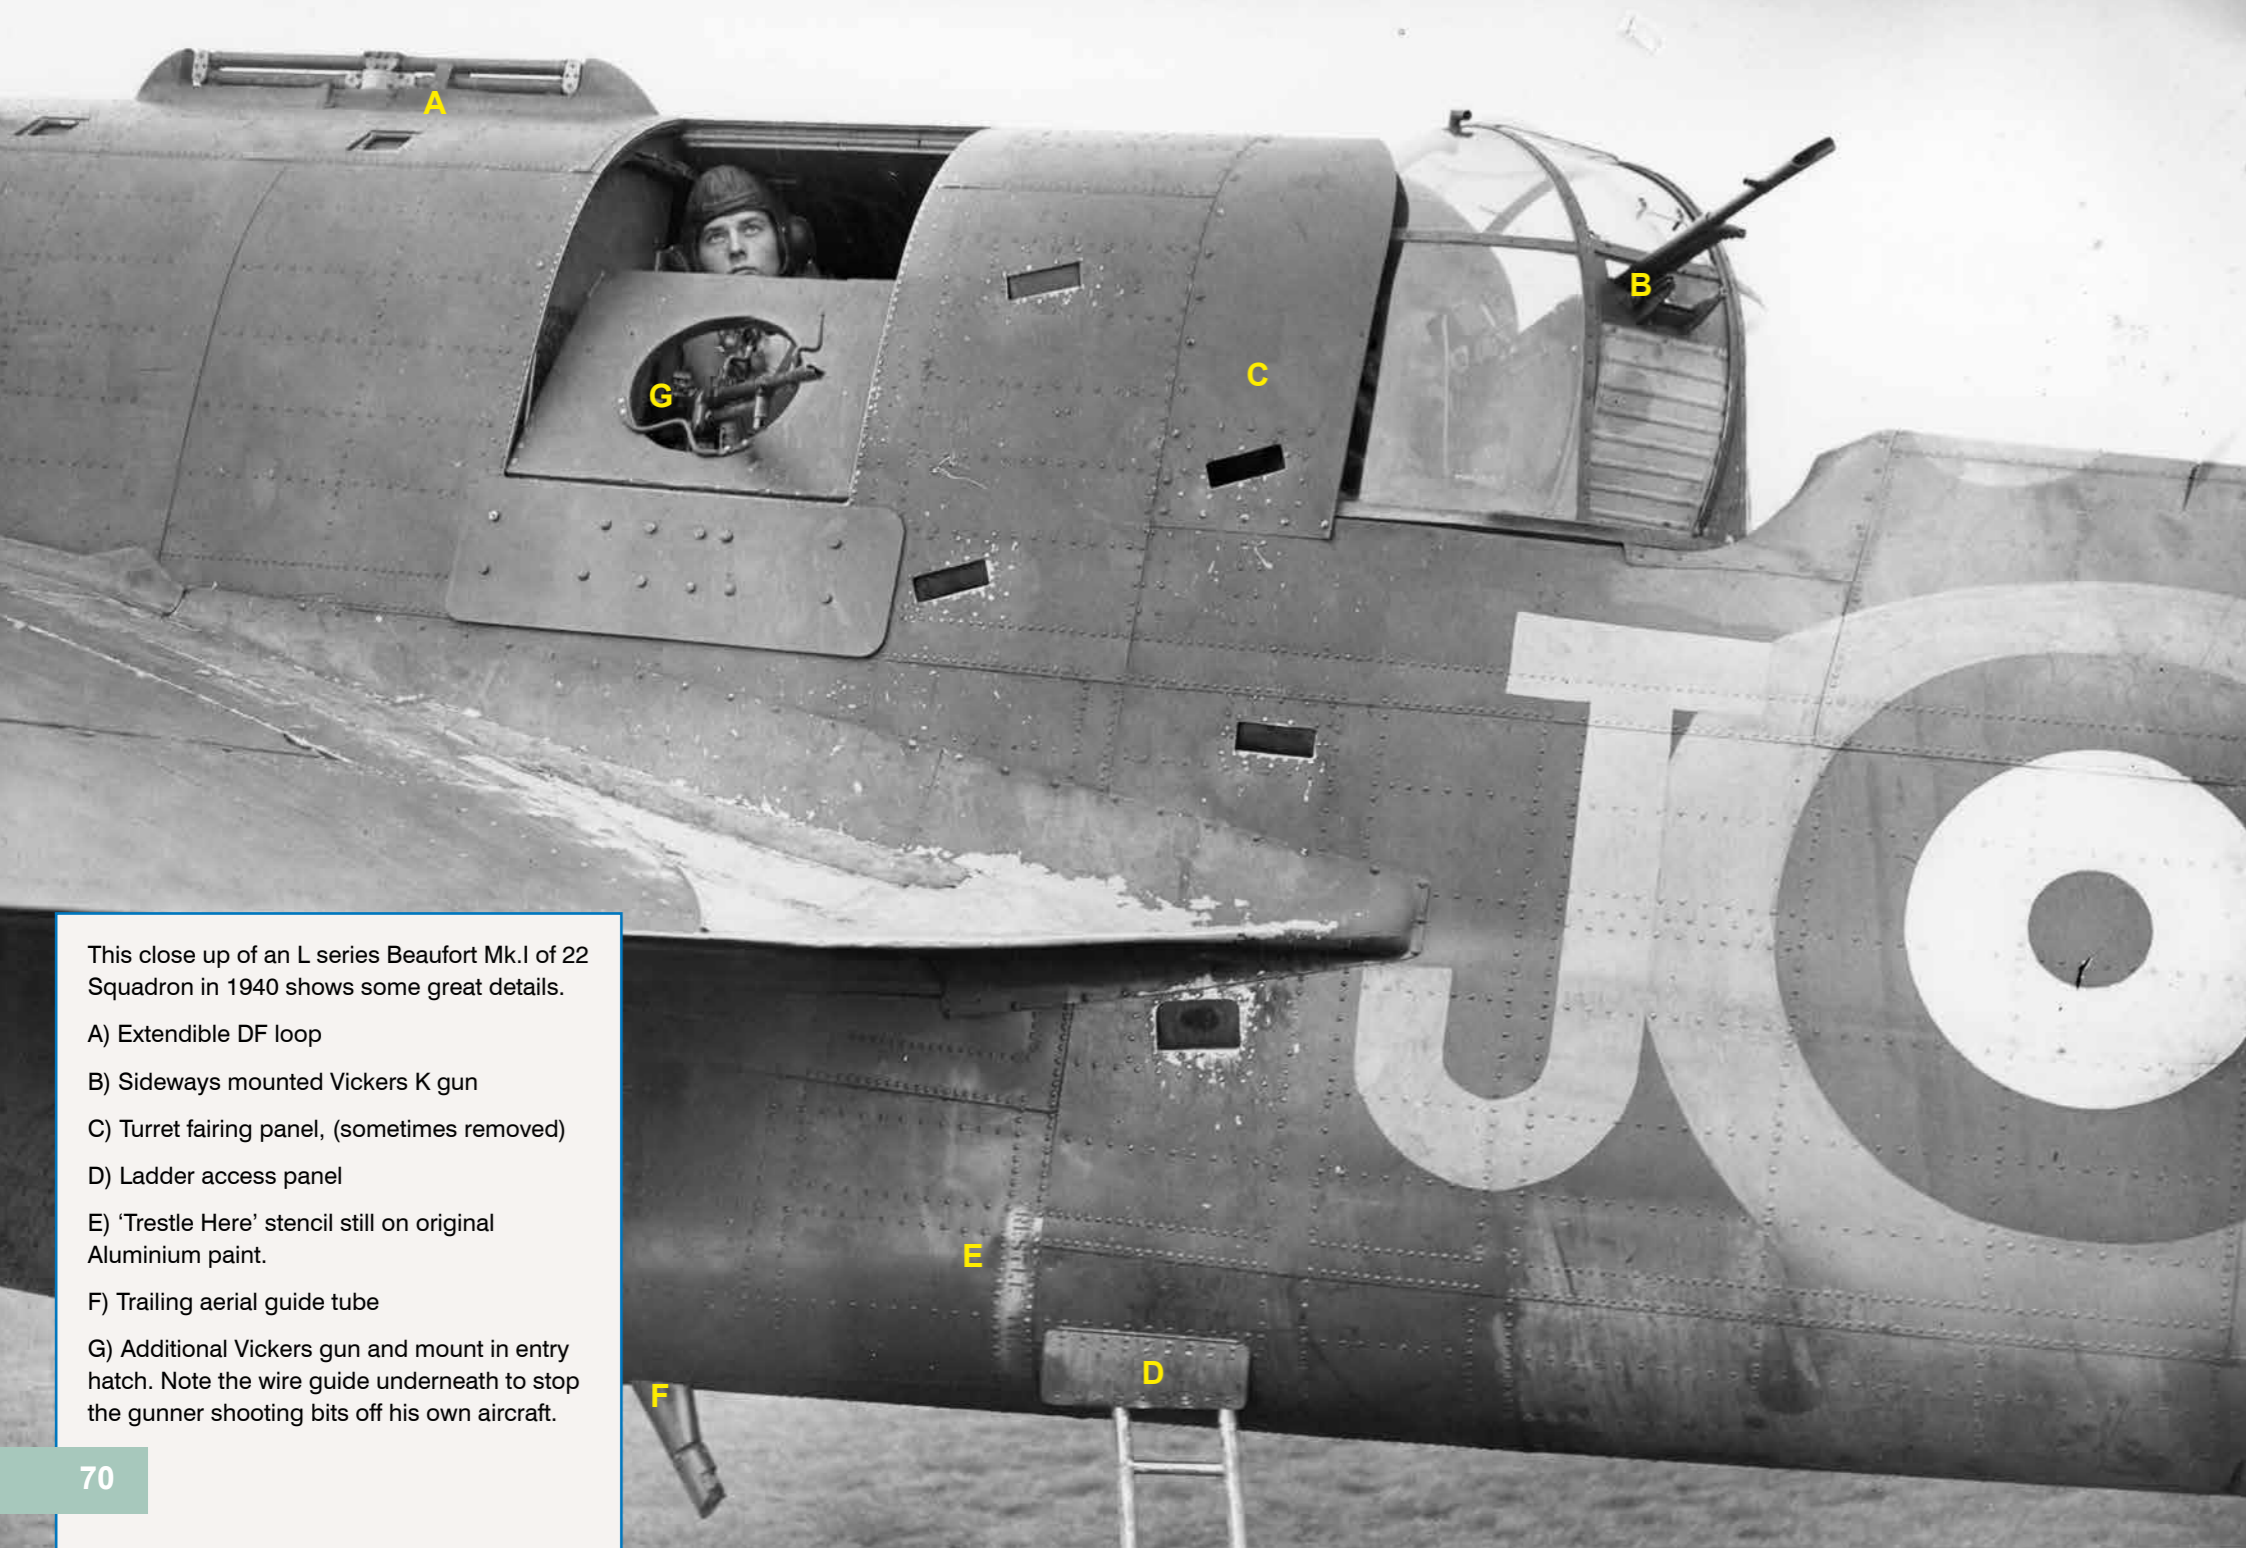
This close up of an L series Beaufort Mk.1 of 22 Squadron in 1940 shows some great details.

- A) Extendible DF loop
- B) Sideways mounted Vickers K gun
- C) Turret fairing panel, (sometimes removed)
- D) Ladder access panel
- E) 'Trestle Here' stencil still on original Aluminium paint.
- F) Trailing aerial guide tube
- G) Additional Vickers gun and mount in entry hatch. Note the wire guide underneath to stop the gunner shooting bits off his own aircraft.

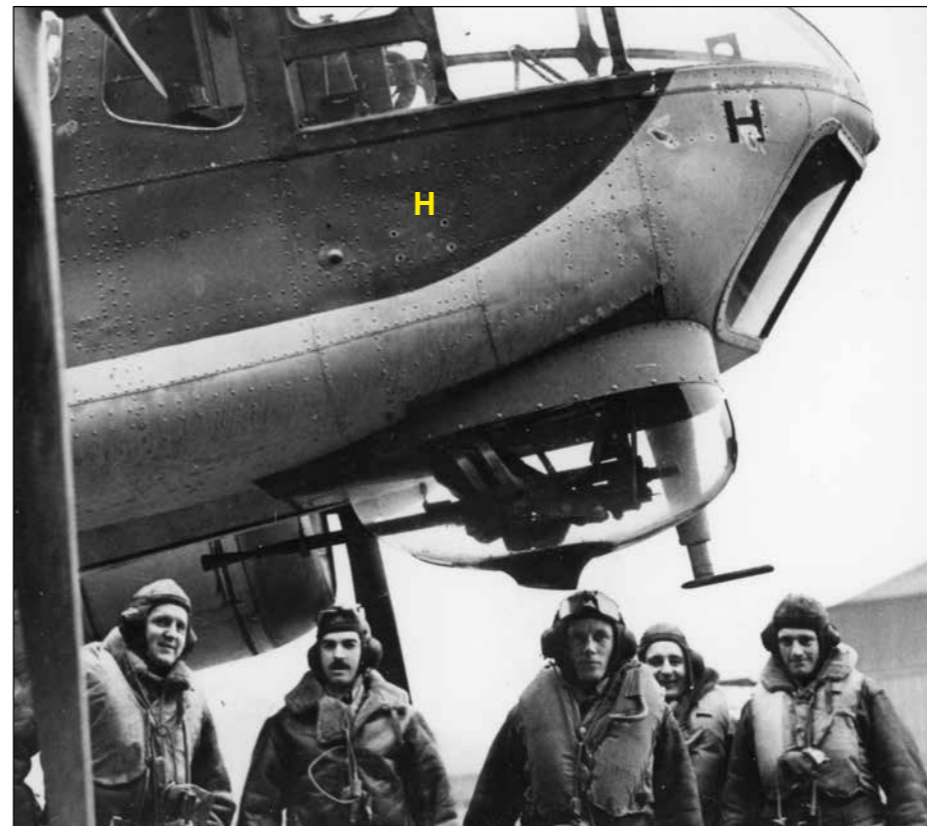
Top left: A side view of the under-nose turret. The five holes at (H) are where the camera gun mount would have been fitted.

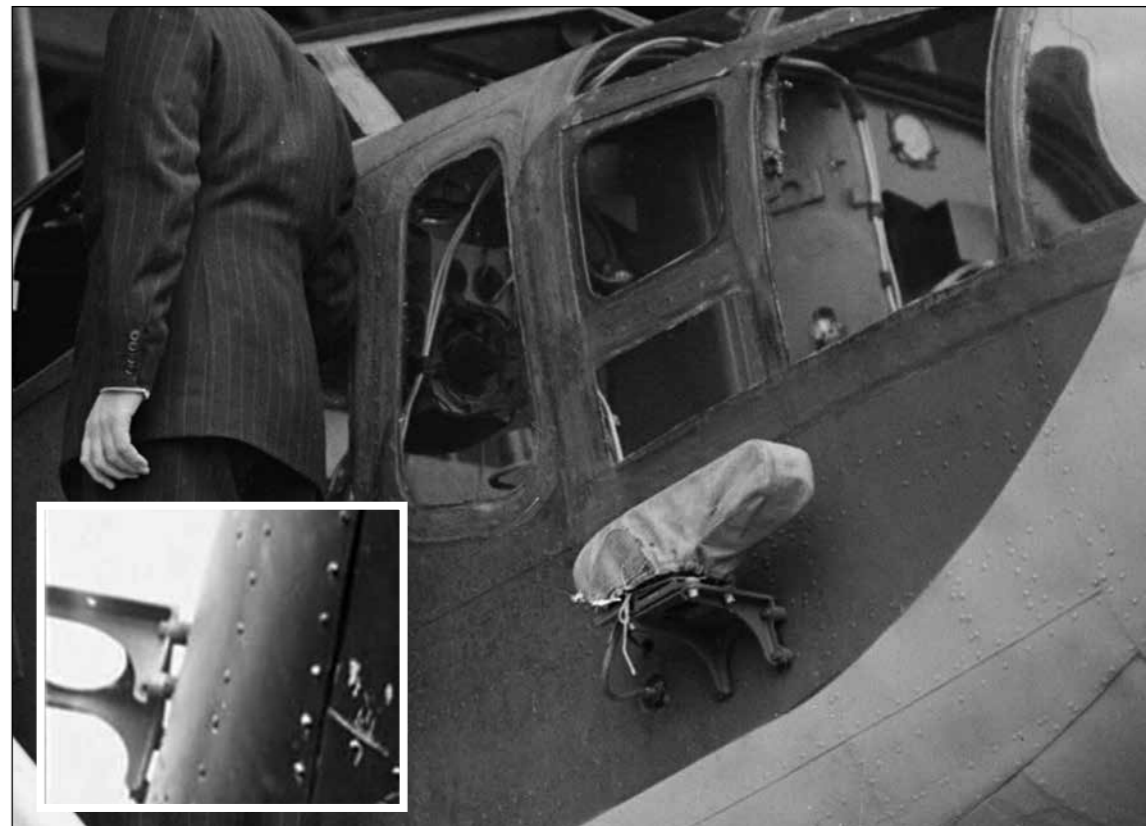
Above: A camera gun fitted on the mount, albeit with a cover on!

Above inset: A close up of the empty mount.

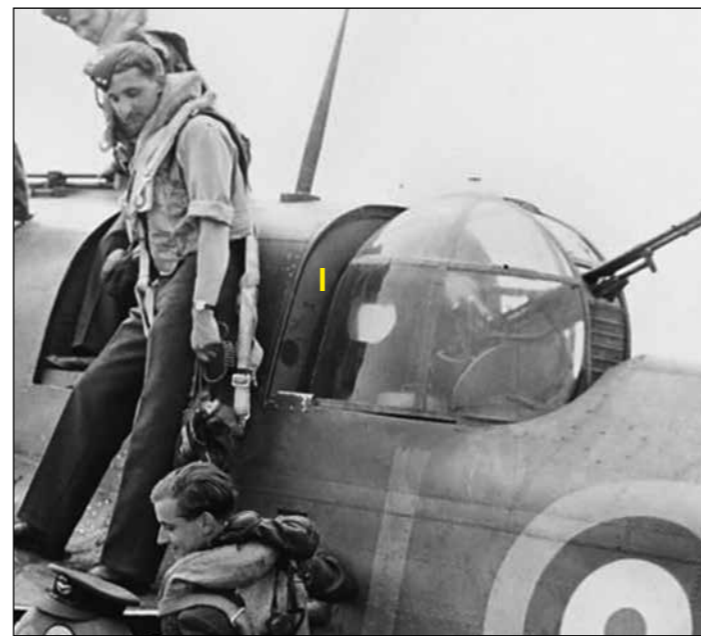
Far left: A close up of the Bristol turret with the fairing removed at (I), compare with the photo opposite. This allowed the turret to shoot at targets on the beam.

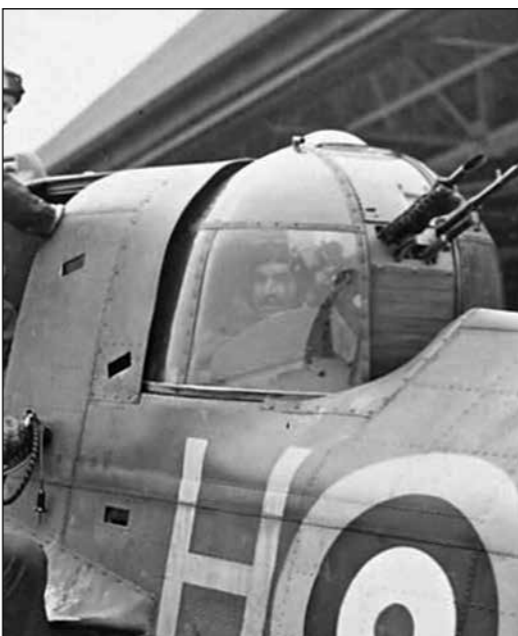
Left: The fairing is fitted on this turret which is one of the later versions fitted with two Vickers K machine guns, the port mounted on its side and the starboard mounted normally.
